Facilities Assessment Report
SMMA

SECTION 2 FACILITIES ASSESSMENT

2.1 DEERFIELD ELEMENTARY SCHOOL

The following is a summary of the existing conditions at the Deerfield Elementary School. This report is based on our site visit on October 29, 2014.

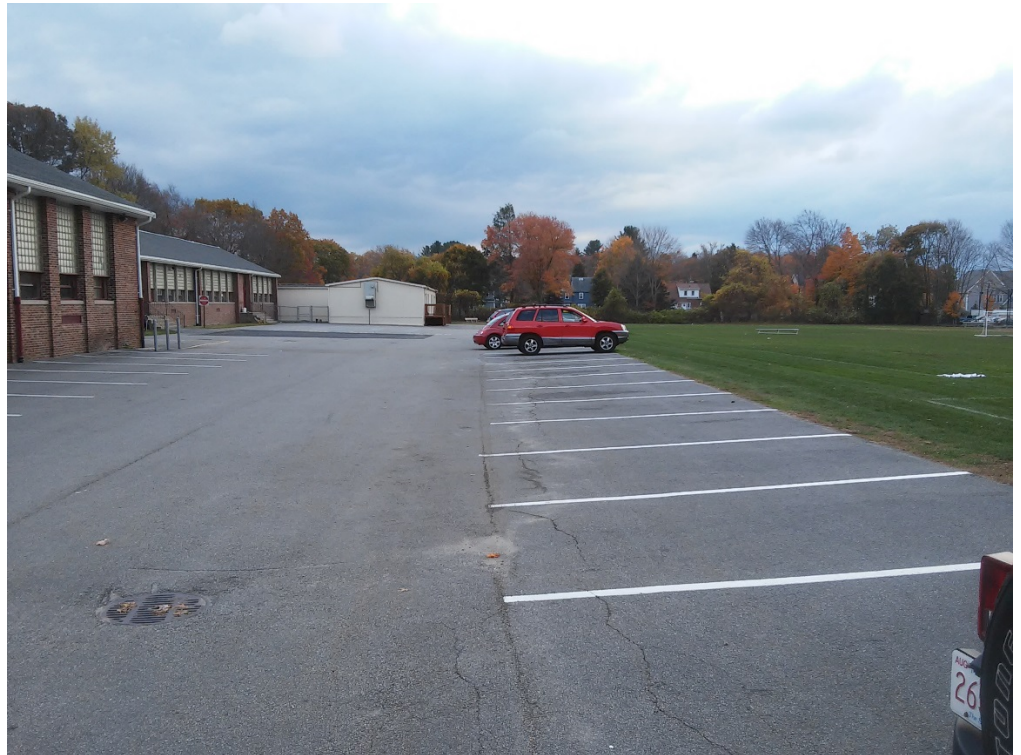
The West Parking Lot is in overall good-fair condition. Bituminous pavement shows minimal wear and some longitudinal and fatigue cracking along the west edge. The striping is clearly visible. No perimeter curbing exists. The lot contains 34 standard parking spaces. The area also serves the dumpster loading/unloading and service area. The building does not have a loading dock.

SEAM AND LONGITUDINAL CRACKING IN WEST PARKING LOT

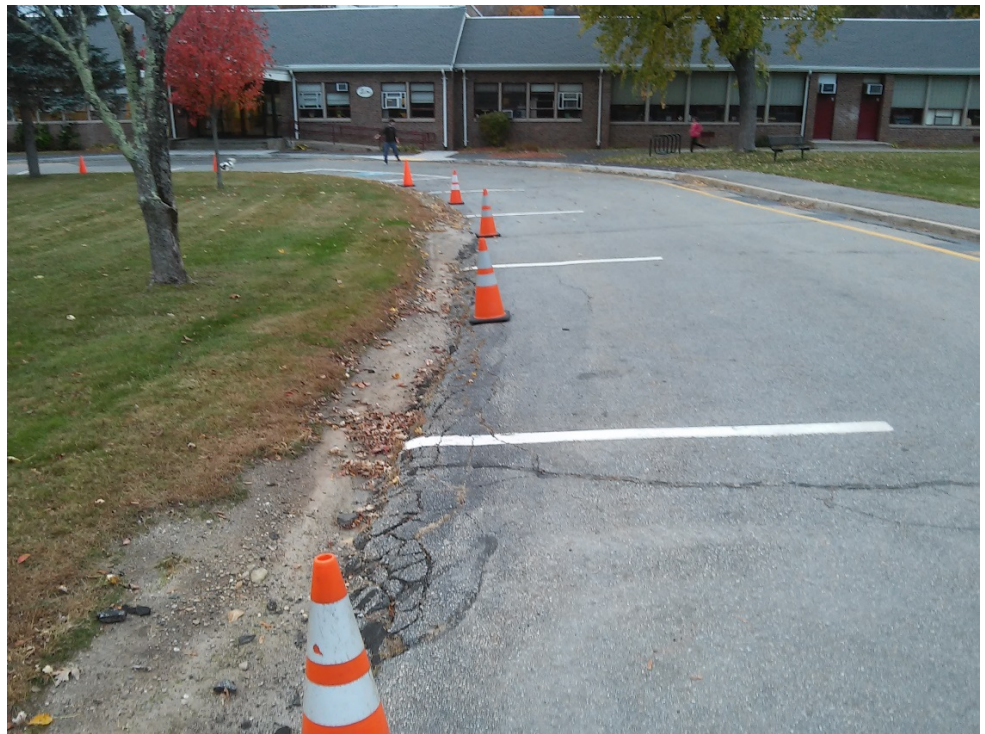
The Front bus loop/parking area is in overall fair condition. The bituminous pavement shows some wear and contains some edge cracking and transverse cracking. Striping is clearly visible. Perimeter curbing exists only on the outside edge and consists of concrete curbing in fair condition. There is some plow damage and deterioration visible on the curbing. A section of new concrete curbing in front of the building was installed within the past two years and is in good condition. The area contains 15 parallel parking spaces (14 standard spaces and 1 accessible spaces). The loop is one-way, and signage prohibits vehicular traffic from 8:00-8:30 AM and 2:30-3:00 PM.

EDGE CRACKING AND ADJACENT RUTTING IN LANDSCAPE AREA AT FRONT BUS LOOP/PARKING AREA

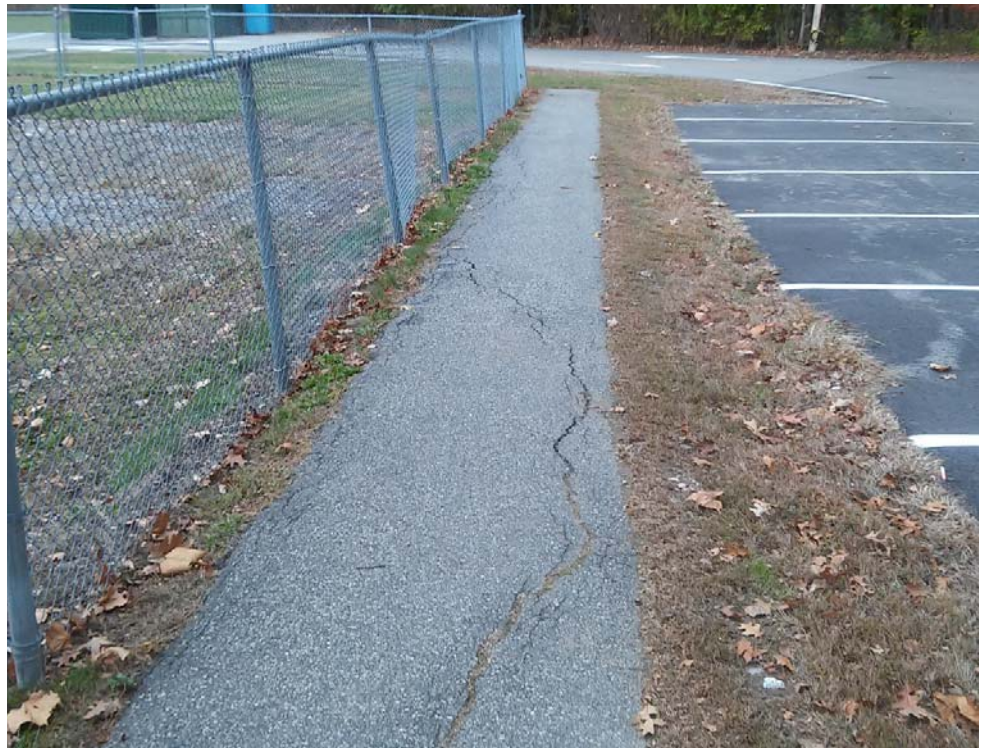
The bituminous walkway adjacent to the North Parking lot is in fair overall condition. The east portion shows some wear and minor cracking, while the west portion contains more significant cracking.

CRACKING AND HEAVING IN WALKWAY ADJACENT TO NORTHERN PARKING AREA

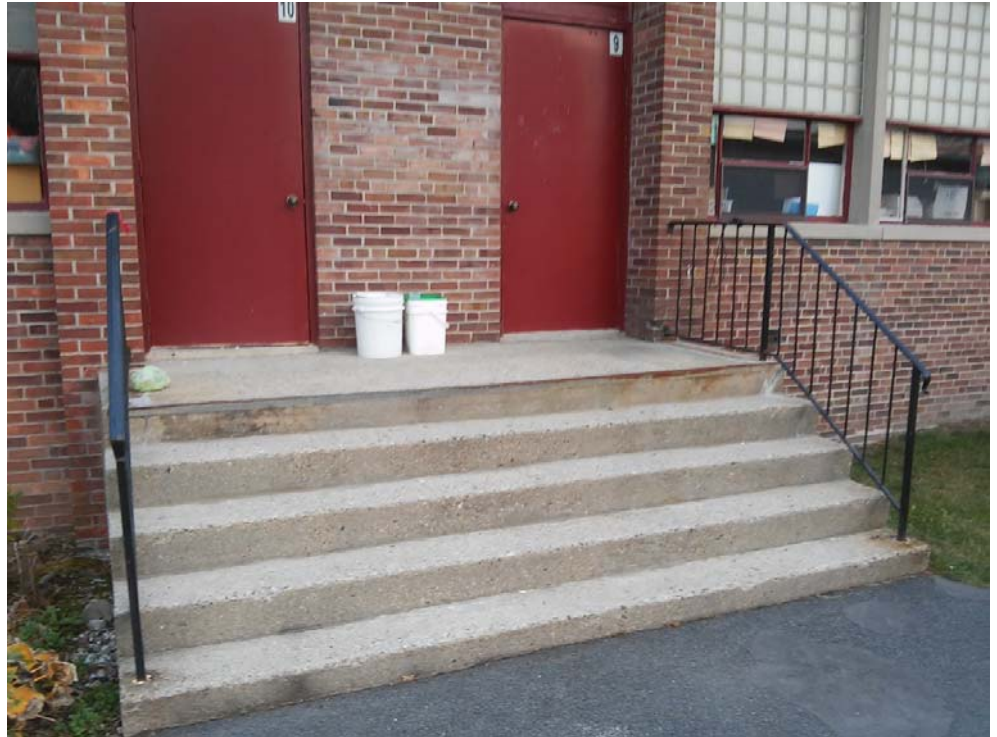
- a. Six building egress points on the west side of the building are not accessible due to stairs (and lack of edge protection for one). Two are wood stairs at the modular building, and the remaining four are concrete stairs. Concrete stairs are in overall fair condition and show some signs of wear and deterioration. One handrail on the wood ramp has loosened from its supports.

NON-ACCESSIBLE BUILDING EGRESS POINT ON WEST SIDE OF BUILDING

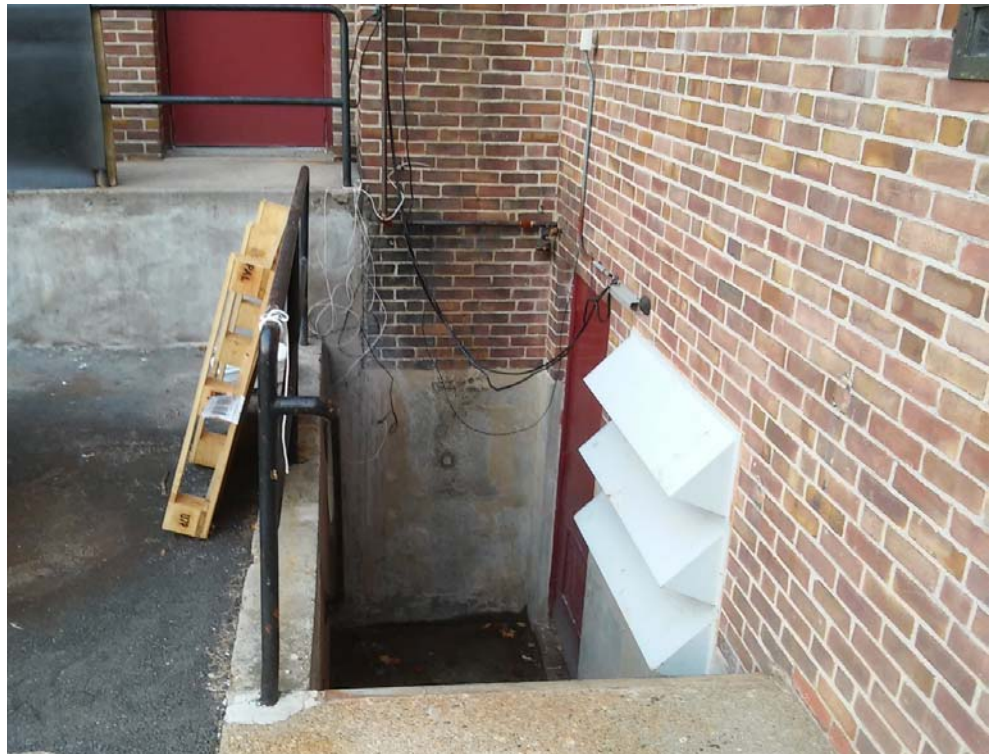
5. Electric/Telecommunications – Several loose, tangled wires observed hanging over the boiler room egress pit. No other known site electrical or telecommunication issues.

HANGING WIRES AND STANDING WATER AT BOTTOM OF LOWER LEVEL EGRESS

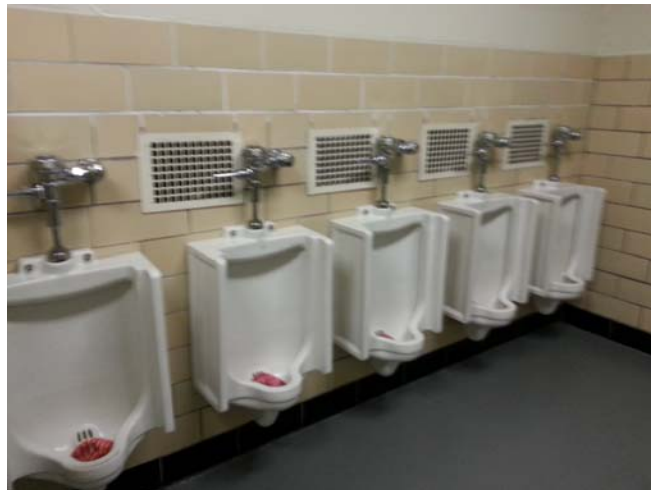
NO PRIVACY SCREENS AT URINALS

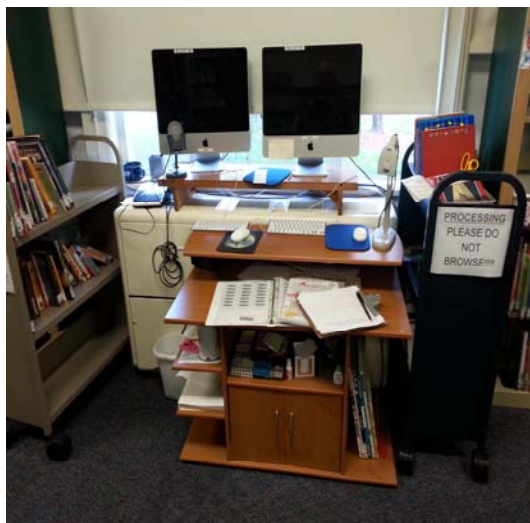
MEDIA CENTER UNIT VENTILATOR. UVs ARE TYPICALLY NEARLY OBSCURED WITH FURNITURE, STACKED TEXTBOOKS AND OTHER TEACHING RESOURCES.

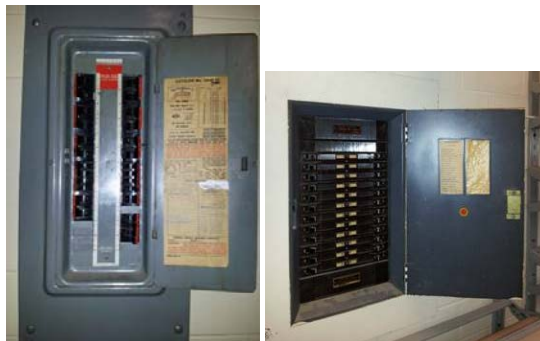
FIG 1: OLD PANELS

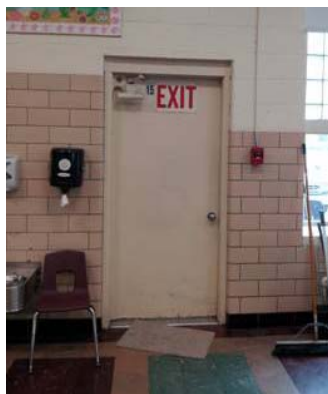
FIG 2: PRINTED EXIT SIGN

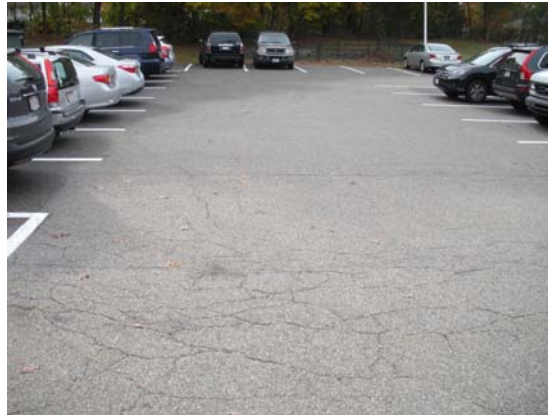
FATIGUE AND BLOCK CRACKING IN SOUTH PARKING LOT

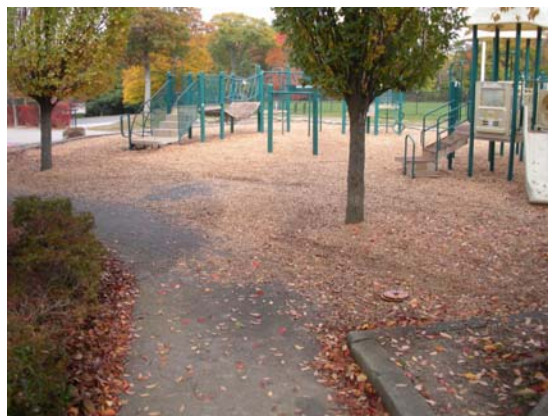
LACK OF ACCESSIBLE PATHS TO PLAY STRUCTURES

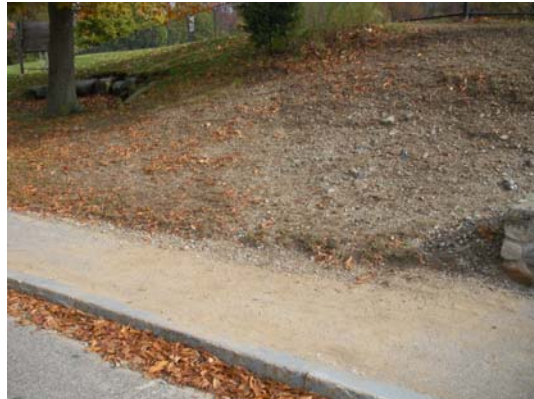
EROSION OF STEEP SLOPE ADJACENT TO PLAYFIELDS

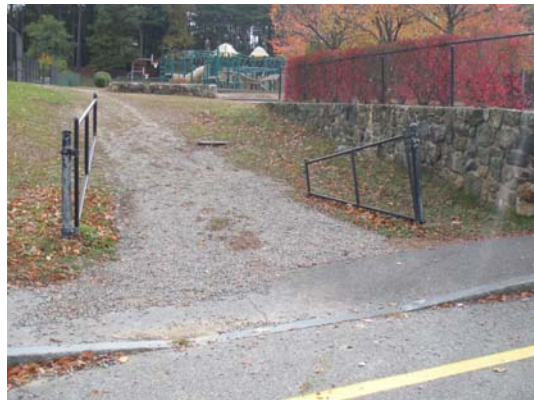
ERODED GRAVEL ACCESS PATH TO GRASS PLAYFIELDS; LACK OF DETECTABLE WARNING PANELS

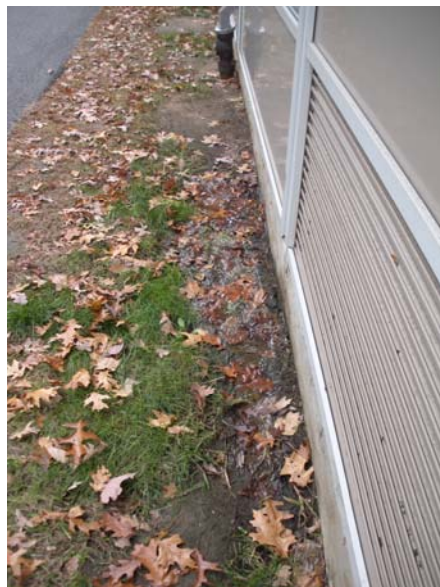
STANDING WATER ALONG BACK (WEST) SIDE OF BUILDING

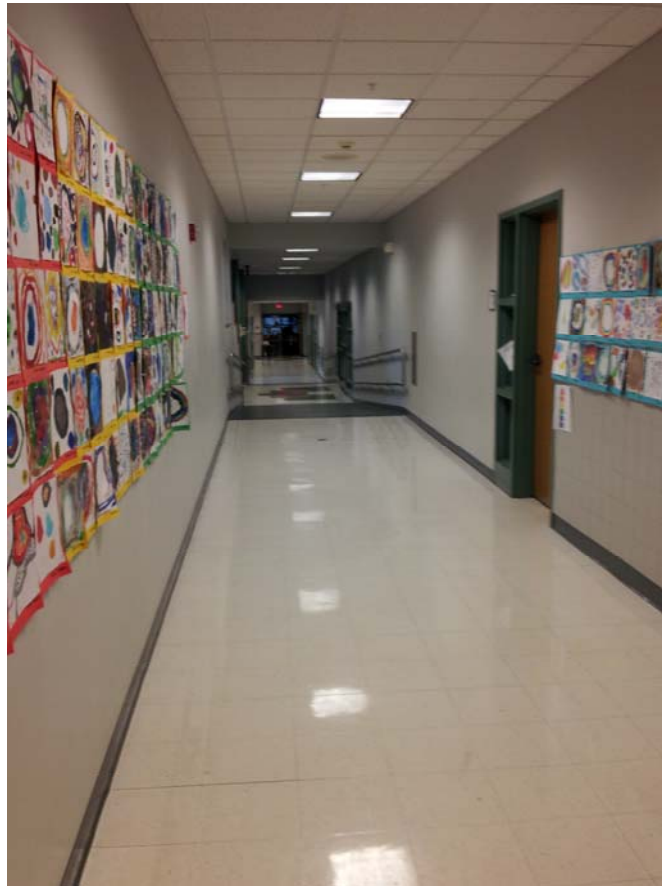
DRY ENVIRONMENT CONDITIONS CAUSE FLOOR AND CABINET PROBLEMS

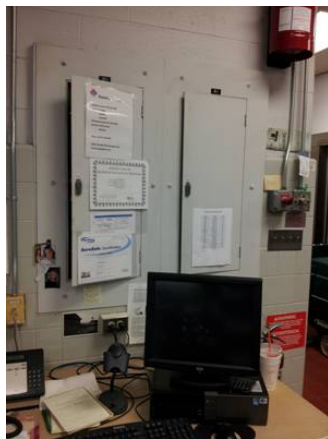
1. Kitchen panel is old/beyond its life expectancy. Power feeder associated with this panel is beyond its life expectancy (fig 1).
2. Kitchen receptacles are non-GFCI type and have no GFCI protections (circuit breakers), which is not in compliance with the current electrical code (MEC), (fig 2).
3. Existing lighting control system does not comply with the current energy code: there are no occupancy sensors, no daylight sensors, and no programmable lighting control system for interior lights.

FIG 1: OLD PANELS

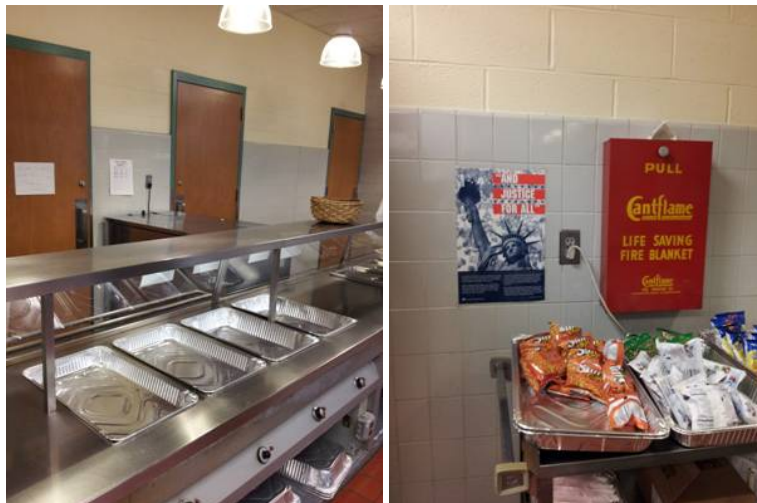
FIG 2: KITCHEN RECEPTACLES

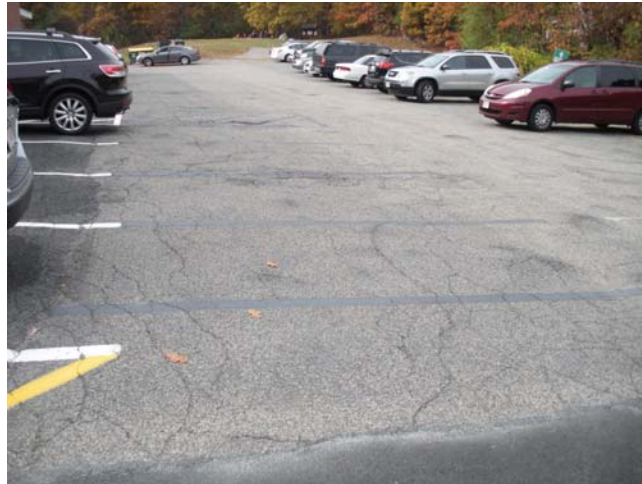
FATIGUE CRACKING AND HEAVING/SETTLEMENT IN NORTH PARKING LOT

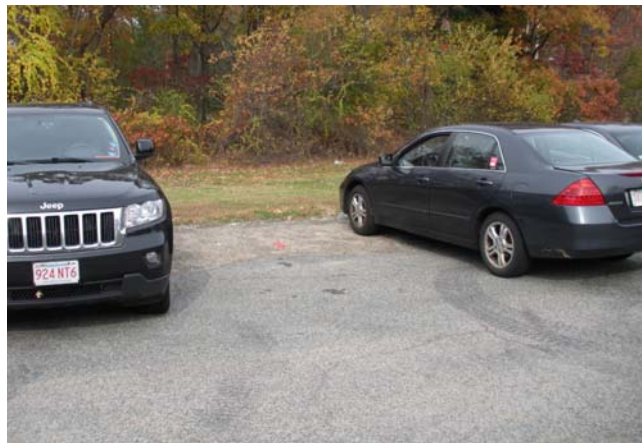
GRAVEL EXTENSION OF PARKING AREA WITH NO CURBING

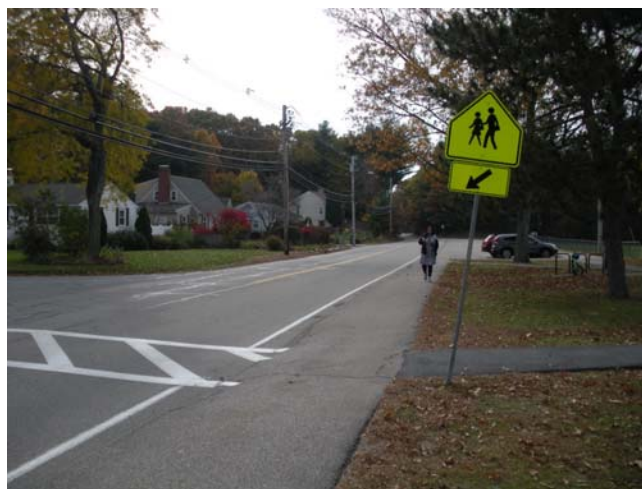
LACK OF DETECTABLE WARNING PANEL AT CURB CUT ONTO GAY STREET

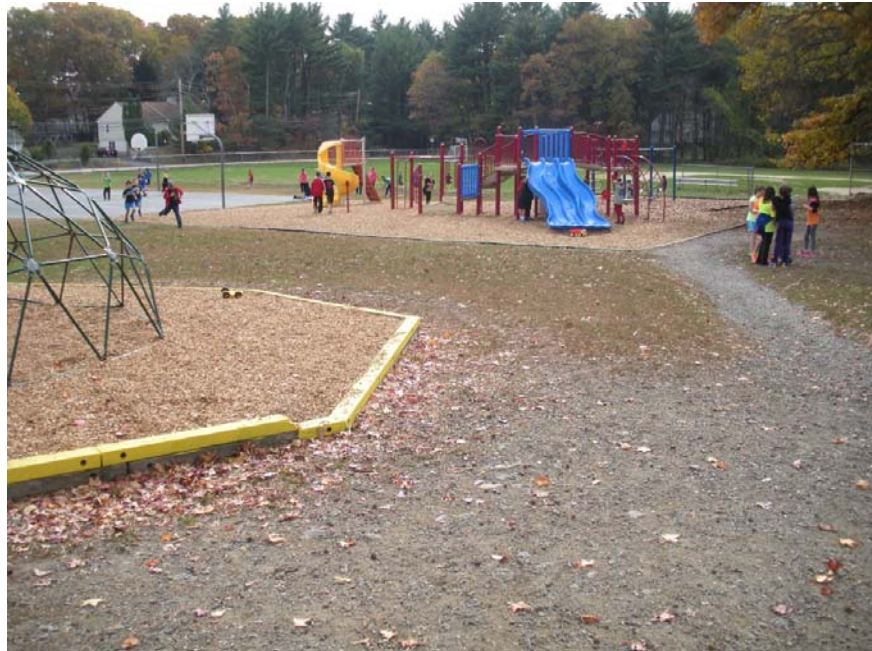
LACK OF ACCESSIBLE PATH TO SOME PLAY AREAS AND STRUCTURES

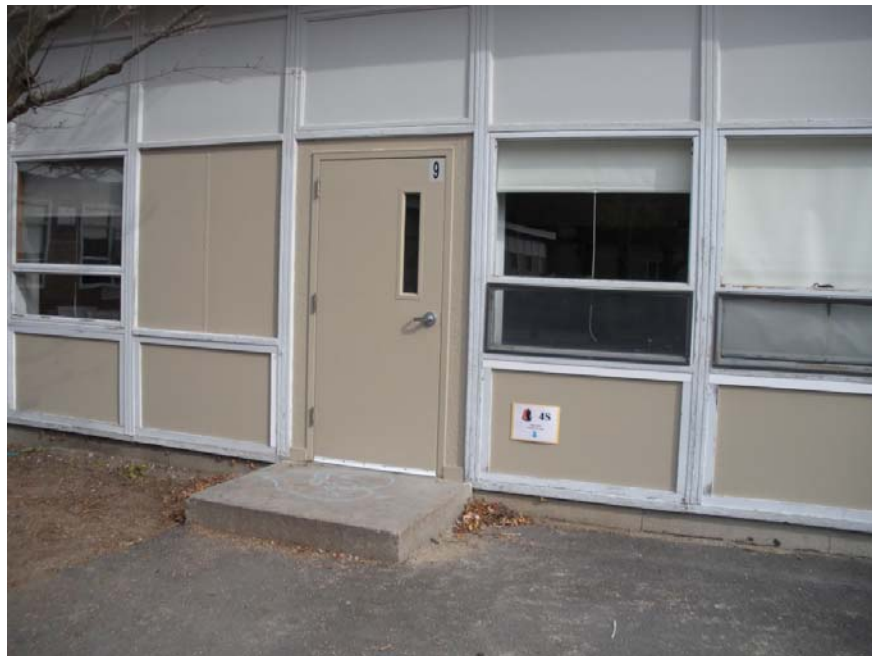
NON-ACCESSIBLE BUILDING EGRESS ON SOUTH SIDE OF BUILDING

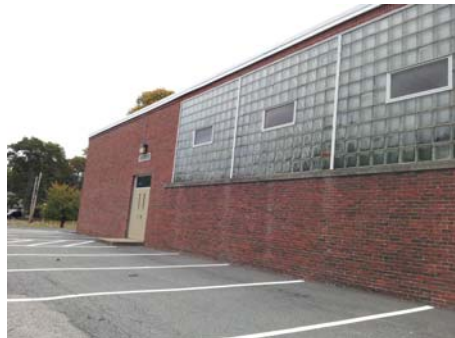
BRICK AND GLASS BLOCK REPOINTING REQUIRED

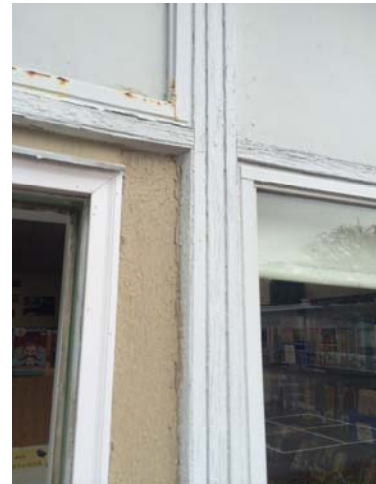
SINGLE GLAZED WINDOWS AND RUSTING STEEL FRAMES

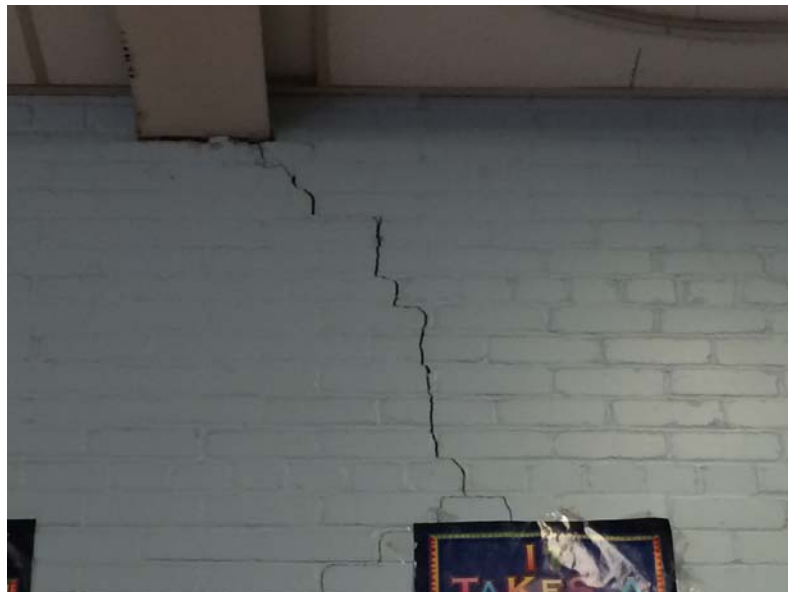
THE ORIGINAL LOAD BEARING BRICK WALLS IN THE ART ROOM (FORMERLY AND AUDITORIUM STAGE), ARE CRACKED BELOW WHERE A STEEL ROOF GIRDER BEARS ON THEM AT EACH END.

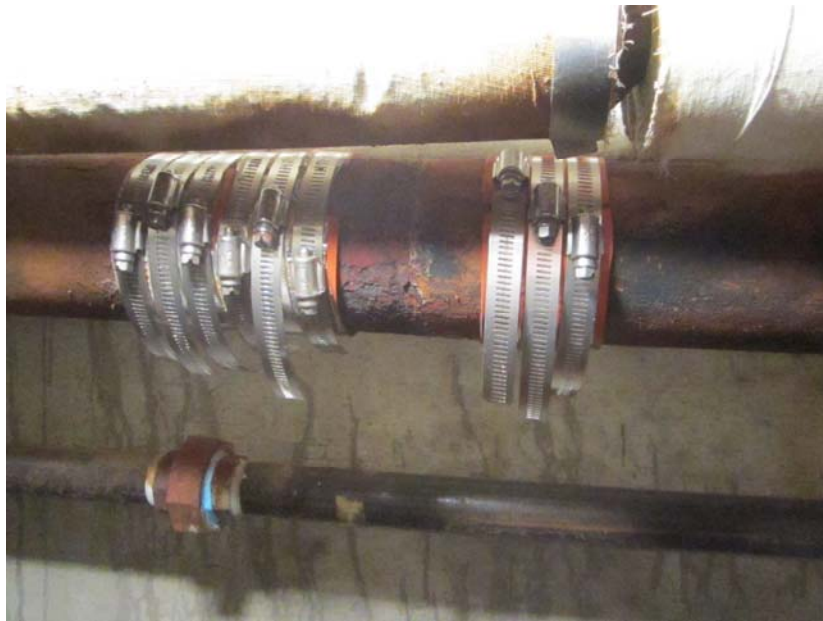
The condensate receiver and pumps are in fair condition. However the piping particularly the condensate is in critically poor condition with multiple leaks being repaired each year in areas that are accessible. Other leaks are occurring in more difficult to access locations and catastrophic failure is a distinct possibility.

PATCHED STEAM PIPING. THE SMALLER DIAMETER CONDENSATE PIPE HAS BEEN REPLACED TO THE RIGHT OF THE UNION (JOINT).

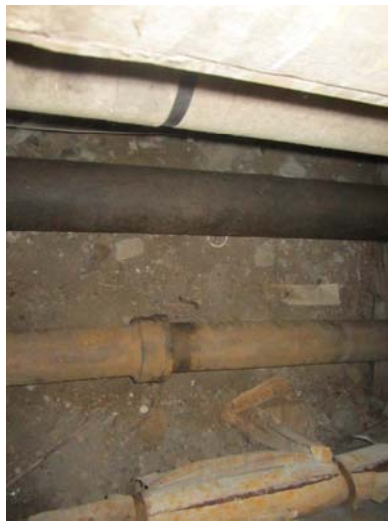
Both of these products are asbestos containing. The insulation, where visible, is in poor condition often due to having been saturated by steam or condensate leaking from the decayed piping. Asbestos laden insulation materials are visible on the sand floor of the tunnels. The tunnels have hatches in many of the classrooms but must be considered confined spaces.

LOOKING DOWN INTO THE STEAM TUNNEL FROM A CLASSROOM HATCH. NOTICE THE DAMAGED ASBESTOS PIPE INSULATION AND DEBRIS ON THE FLOOR.

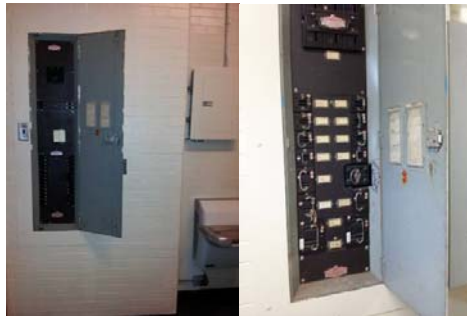
FIG 1: OLD PANELS

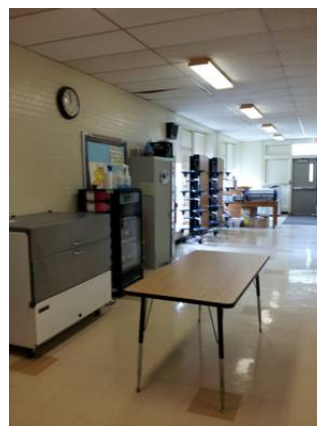
FIG 3: INADEQUATE LIGHTING LEVELS

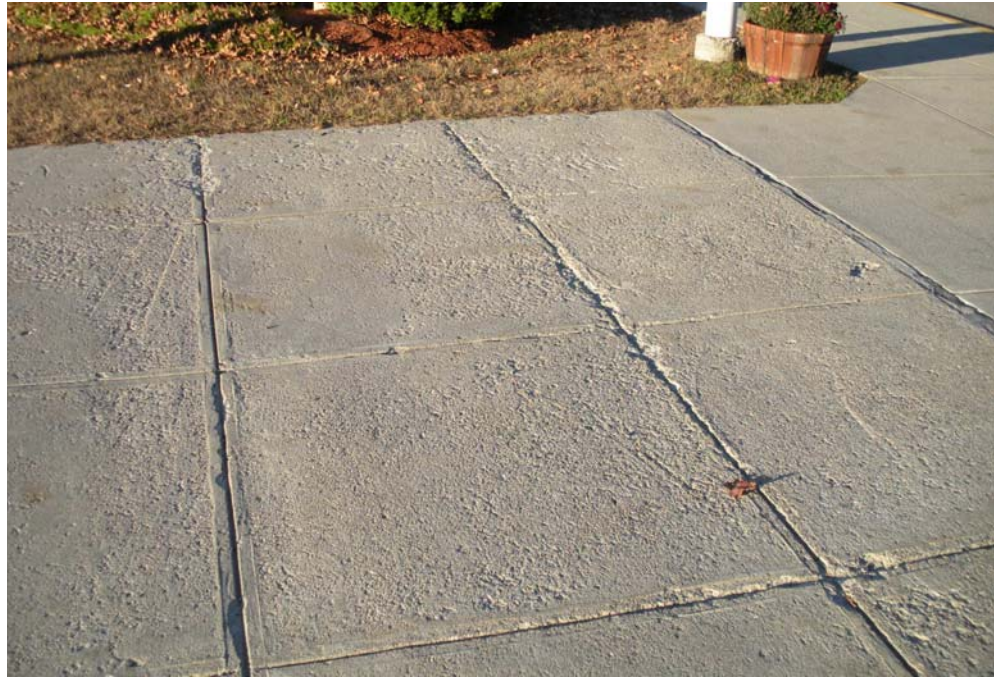
CONCRETE DETERIORATION IN PLAZA/WALKWAY NEAR FRONT ENTRANCE

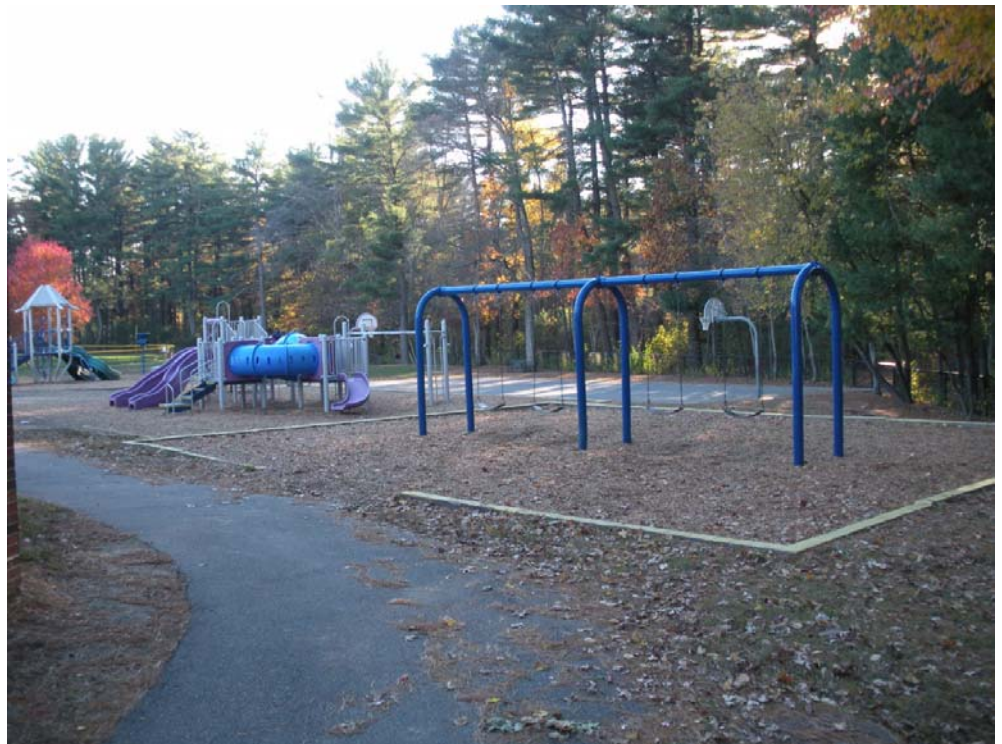
LACK OF ACCESSIBLE PATHS TO PLAY STRUCTURES

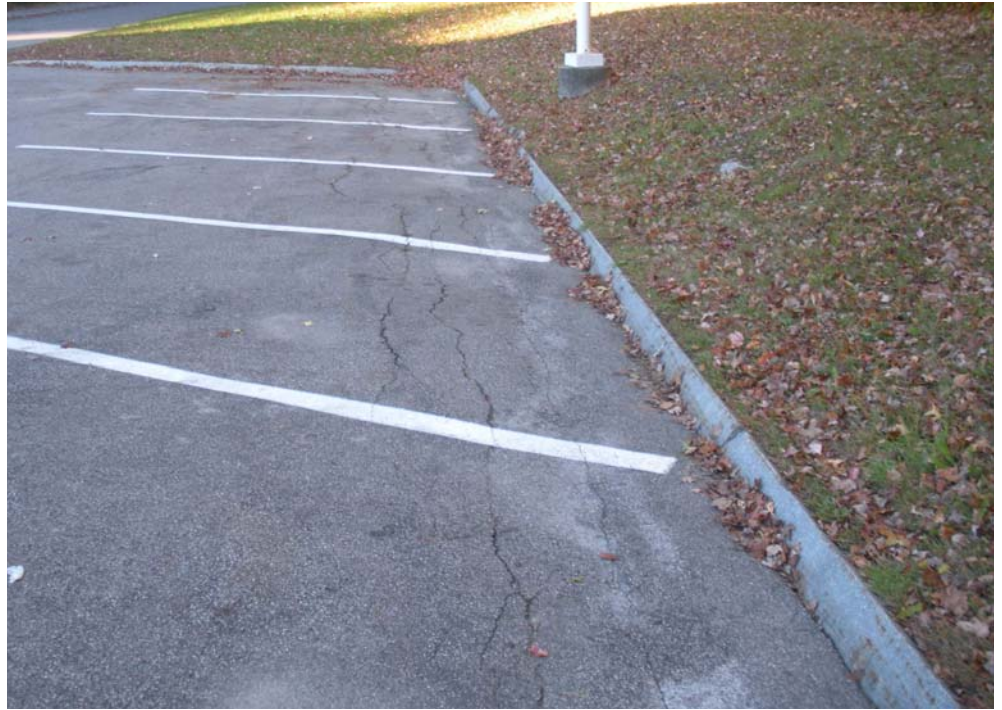
FATIGUE CRACKING AND SETTLEMENT ALONG EDGE OF EAST PARKING LOT

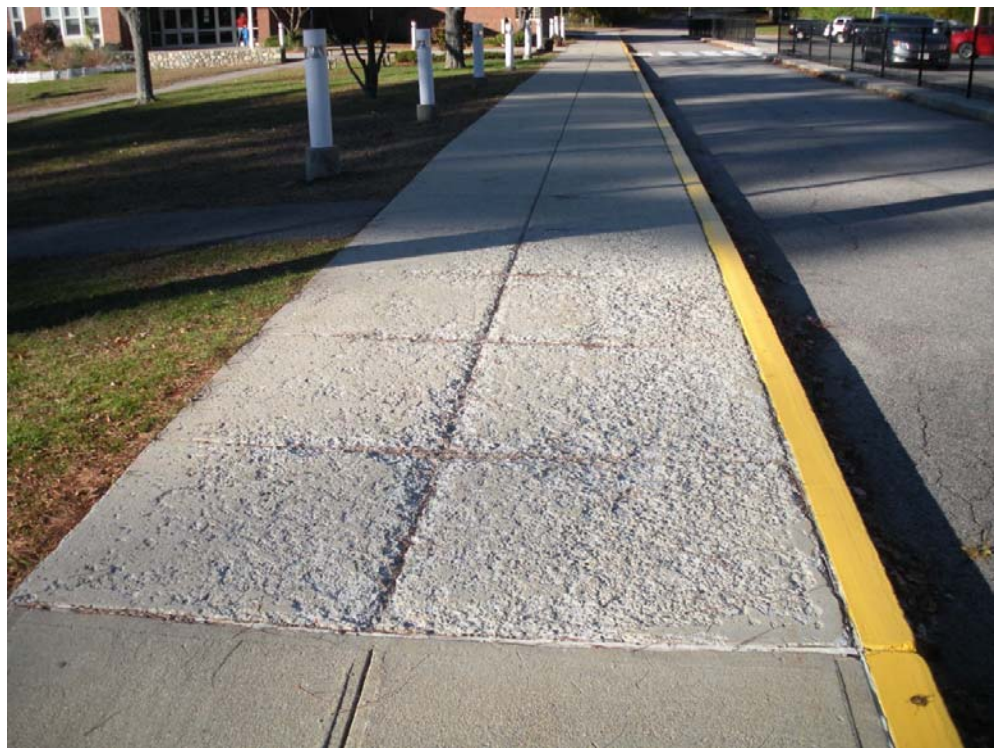
CONCRETE DETERIORATION AT WALKWAY ADJACENT TO BUS LANE

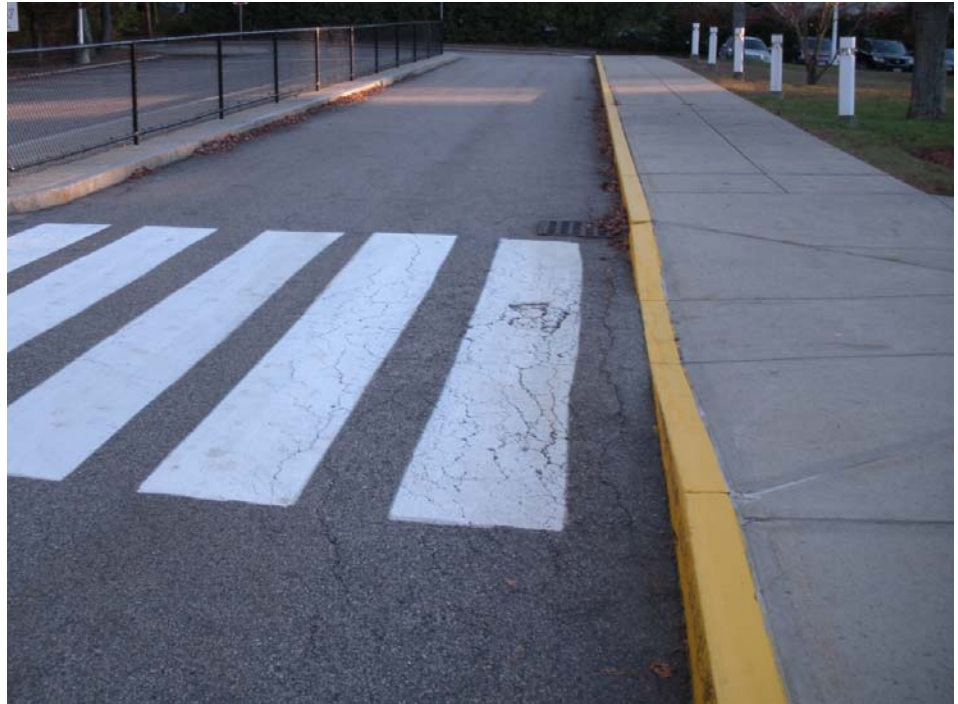
LACK OF DETECTABLE WARNING PANEL AT BUS LOOP CURB CUT, AND PAVEMENT CRACKING

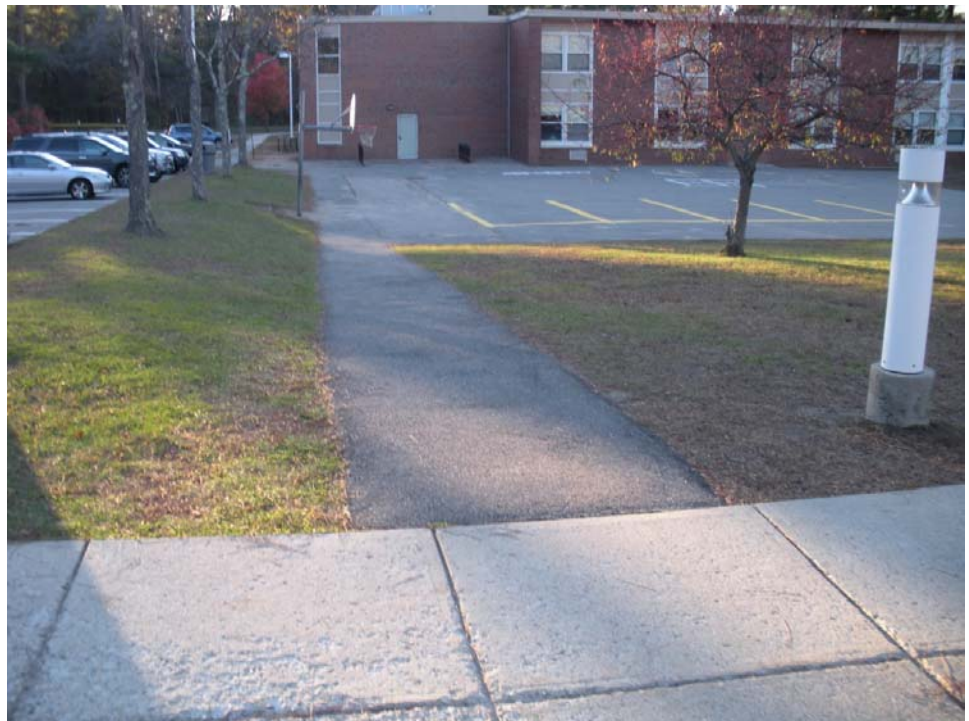
WALKWAY TO BITUMINOUS PLAY AREA/BASKETBALL COURT EXCEEDS MAAB SLOPE REQUIREMENTS

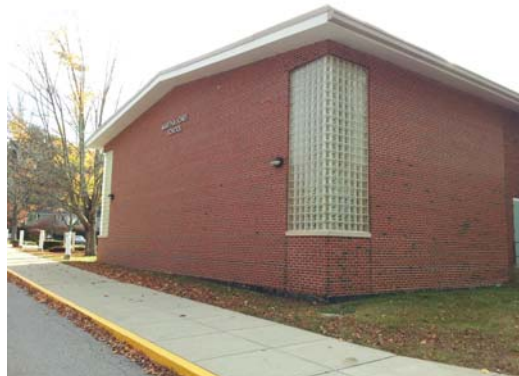
A FEW HAIRLINE CRACKS IN GLASS BLOCK MORTAR JOINTS

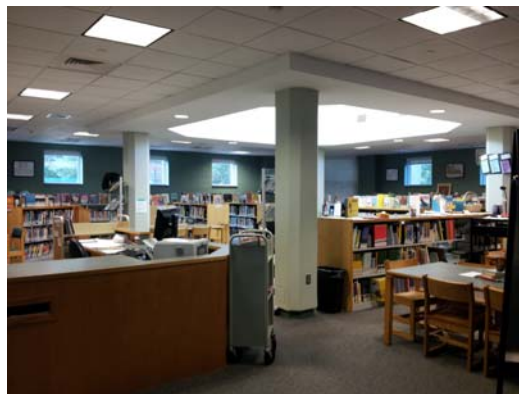
ROOF LEAKS AT MONITOR IN THE LIBRARY

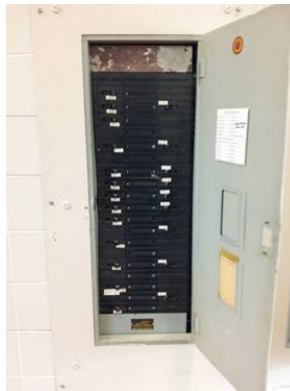
1. One of Kitchen panels appear to be old/beyond its life expectancy. Power feeder associated with this panel is beyond its life expectancy (fig 1).
2. Kitchen receptacles are non-GFCI type and have no GFCI protections (circuit breakers) which is not in compliance with the current electrical code (MEC), (fig 2).
3. Existing lighting control system does not comply with the current energy code: there are no occupancy sensors, no daylight sensors, and no programmable lighting control system for interior lights.

FIG 1: OLD PANEL

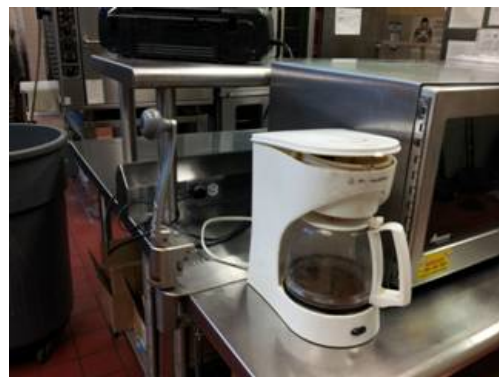
FIG 2: NON-GFCI RECEPTACLES

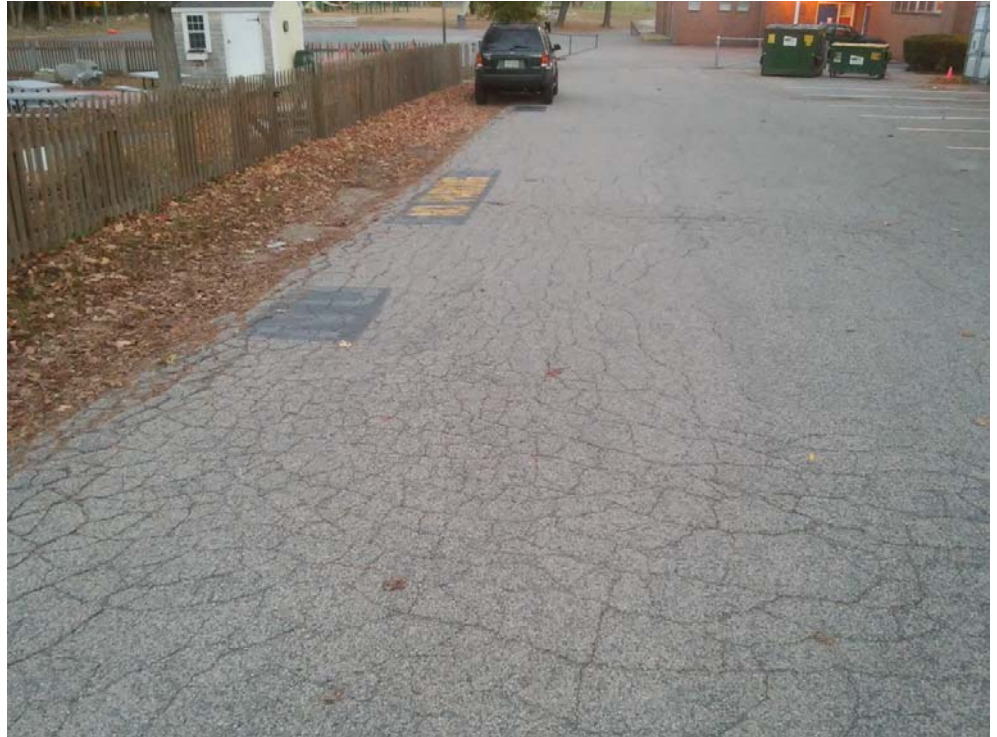
FATIGUE CRACKING IN NORTHWEST PARKING AREA/ACCESS DRIVE

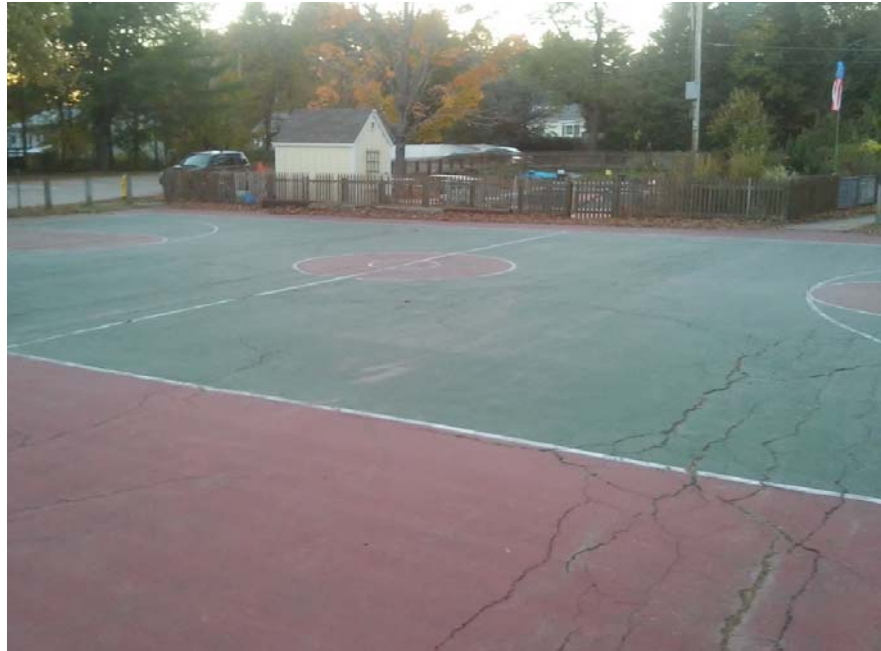
FATIGUE AND TRANSVERSE CRACKING AT BASKETBALL COURTS

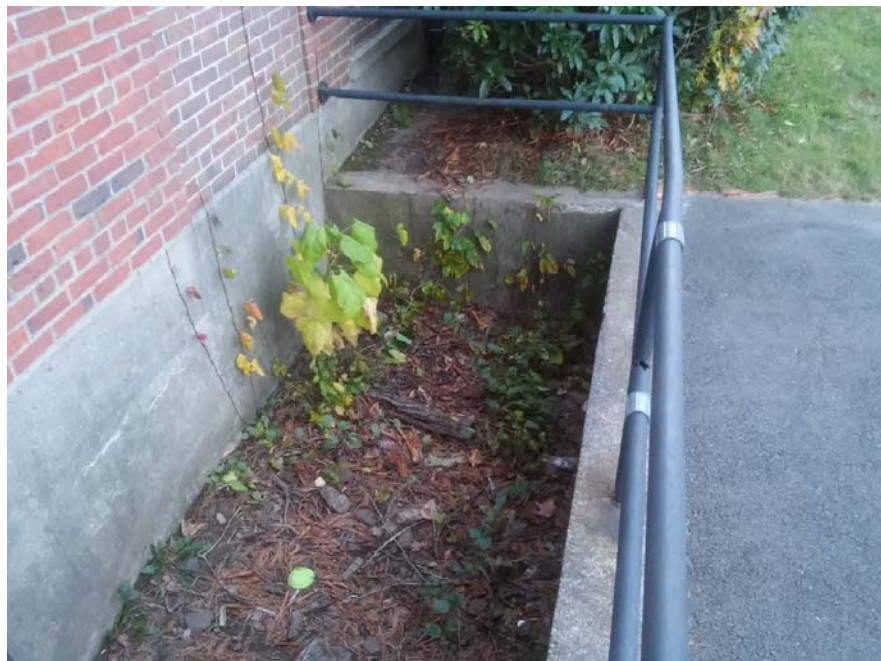
LOWER LEVEL PIT/EGRESS AT BOILER ROOM CLOGGED WITH DEBRIS AND VEGETATION

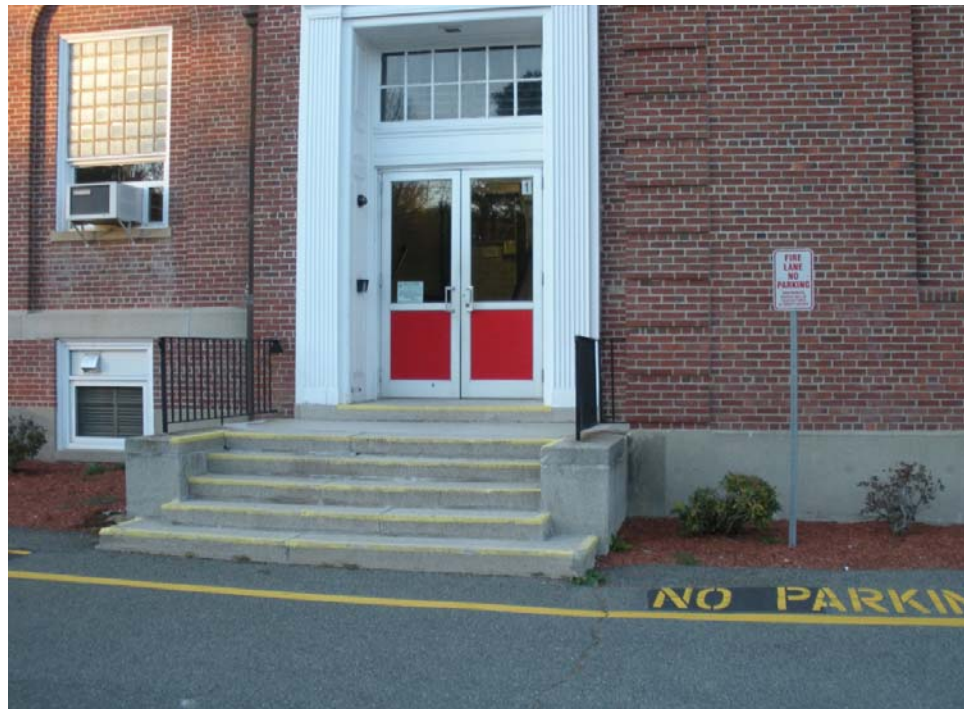
NON-ACCESSIBLE FRONT ENTRANCE AND NON-COMPLIANT HANDRAILS

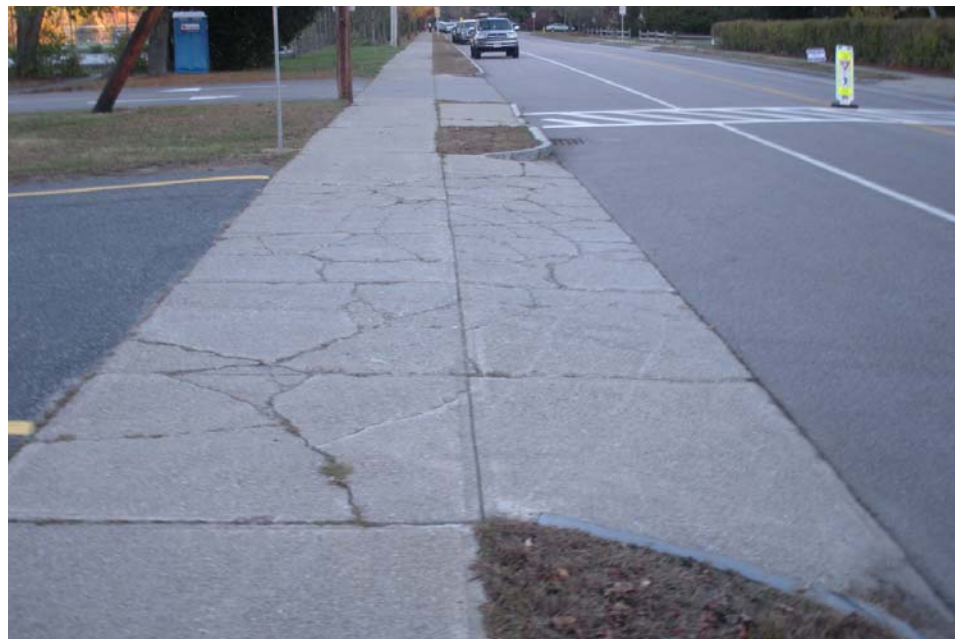
BLOCK AND FATIGUE CRACKING AT CONCRETE ENTRANCE APRONS

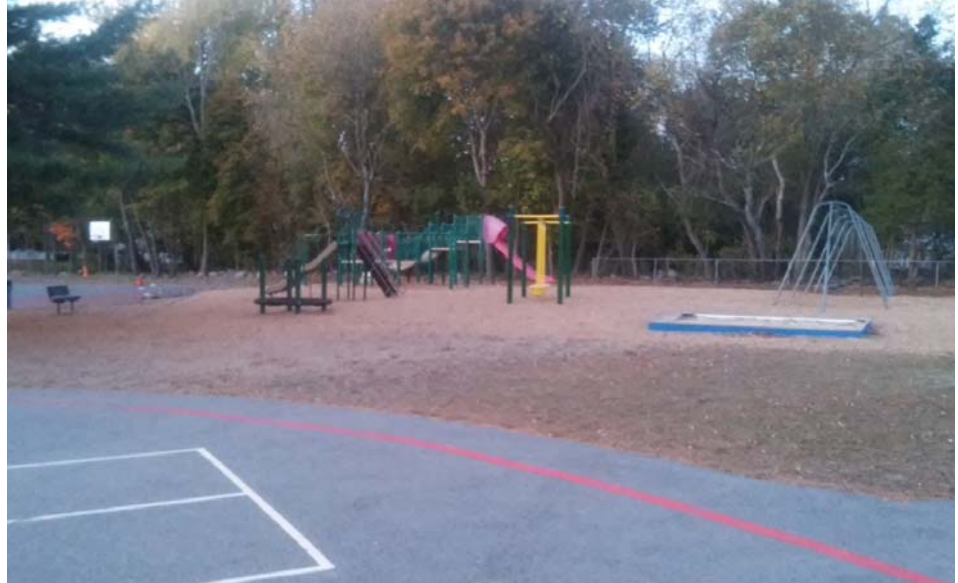
NO ACCESSIBLE ROUTES PROVIDED TO THE WOOD-FIBER PLAY AREA AND STRUCTURES

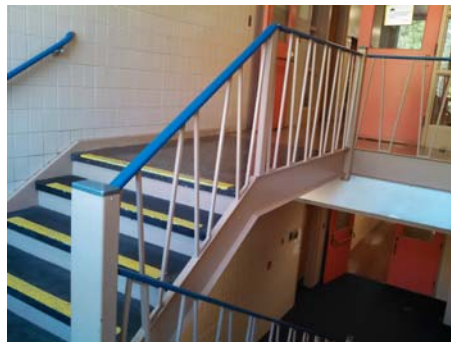
NON-COMPLIANT STAIR GUARD AND HAND RAILS

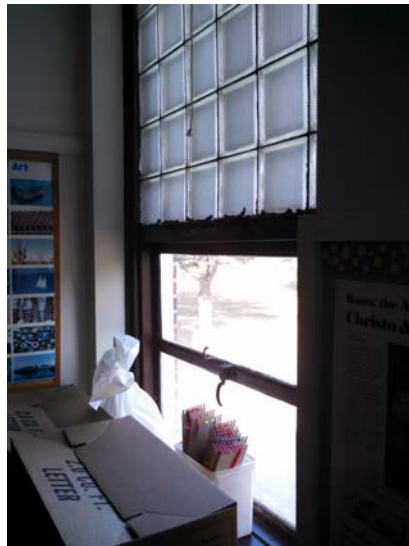
RUSTING STEEL FRAME WINDOWS IN GLASS BLOCK

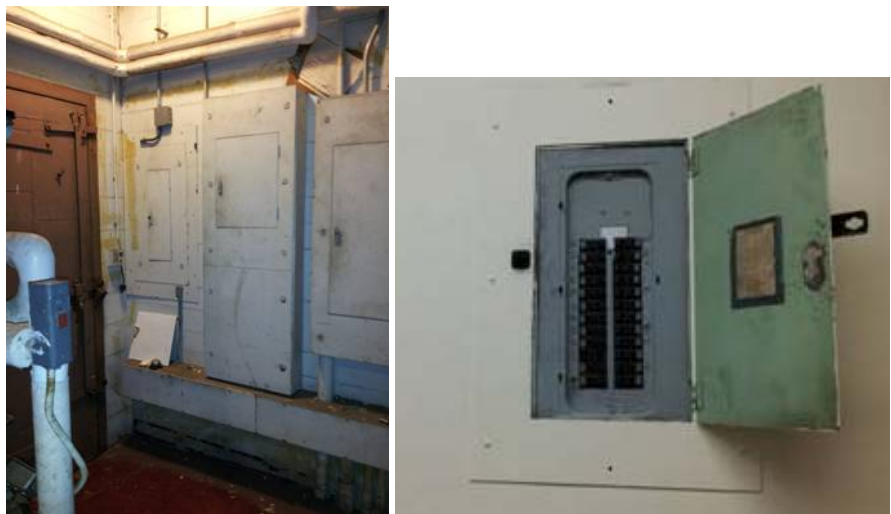
FIG 1: OLD PANELS

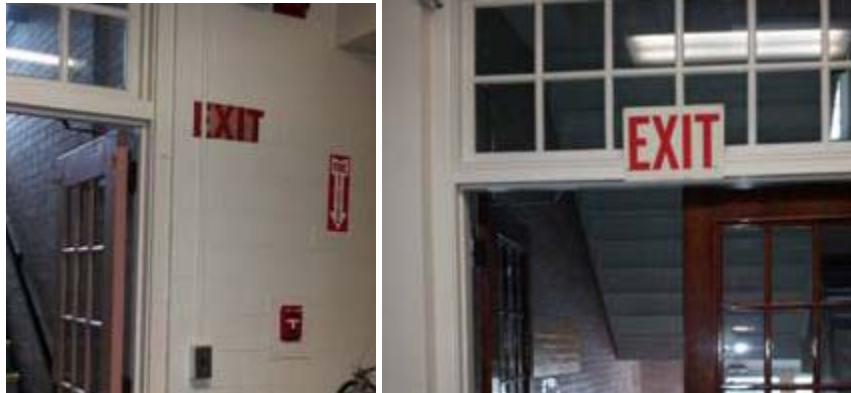
FIG 2: EXISTING EXIT SIGNS

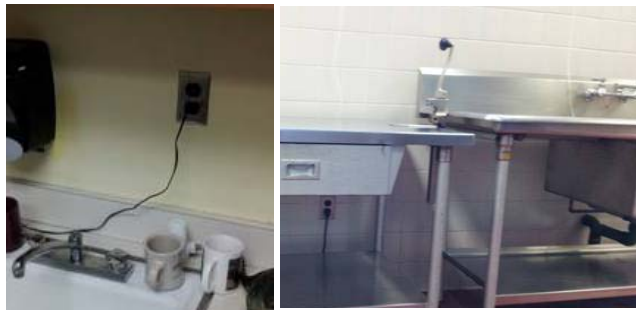
FIG 3: RECEPTACLES NEAR SINKS

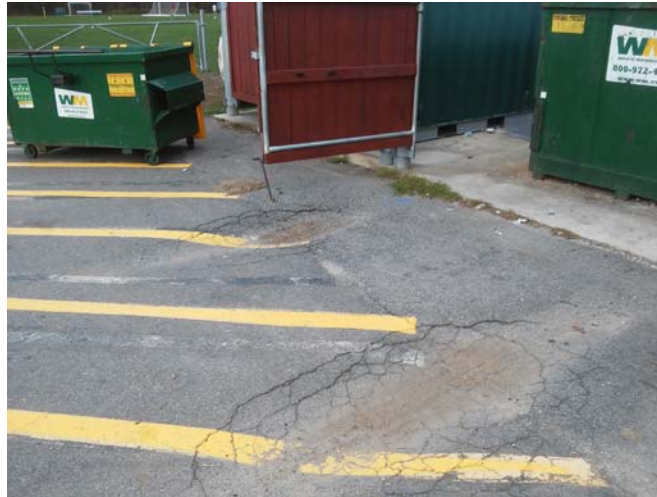
PAVEMENT RUTTING AT DUMPSTER AREA
