Facilities Assessment Report
SMMA

SECTION 2 FACILITIES ASSESSMENT

2.1 DEERFIELD ELEMENTARY SCHOOL

The following is a summary of the existing conditions at the Deerfield Elementary School. This report is based on our site visit on October 29, 2014.

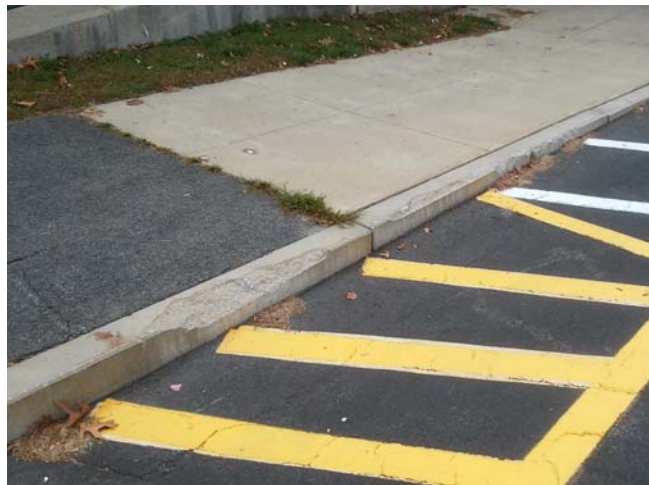
CONCRETE CURB DAMAGE/DETERIORATION NEAR NORTHEAST ENTRANCE

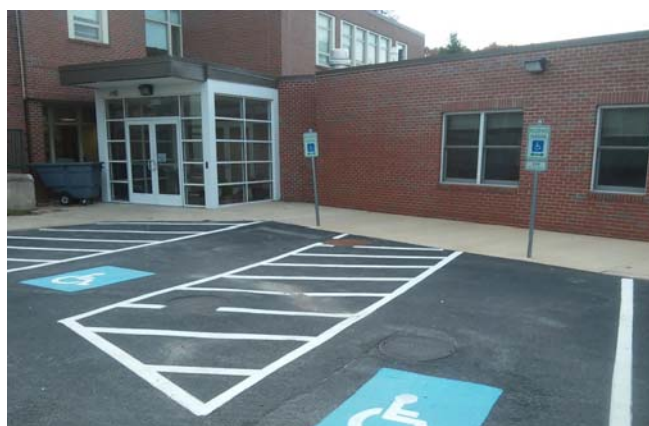
LACK OF CURBING, WHEELSTOPS AND BOLLARDS AT NORTHEAST ENTRANCE

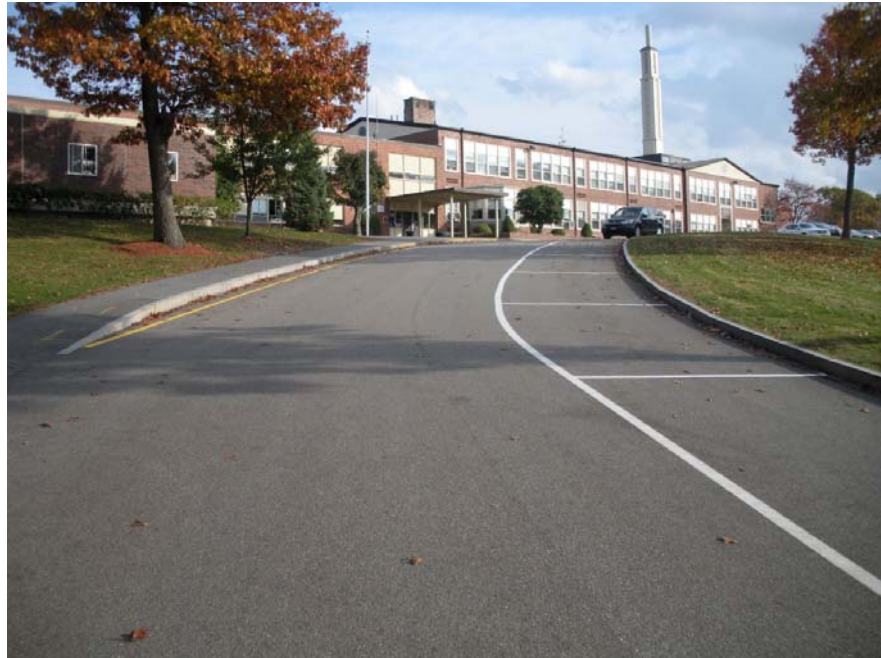
WALKWAY ALONG FRONT BUS/PARKING LOOP THAT EXCEEDS MAAB SLOPE REQUIREMENTS

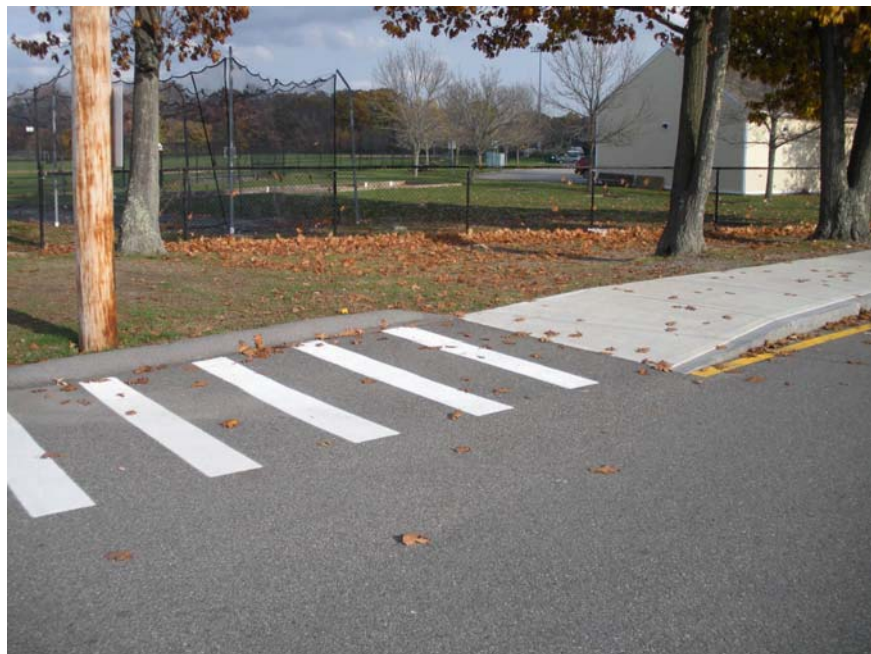
CURB RAMP LACKING DETECTABLE WARNING STRIP AT INTERSECTION OF FRONT BUS LOOP AND PARENT QUEUE LOOP

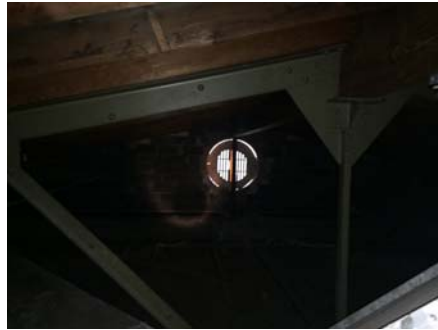
ATTIC LOUVER LEAK

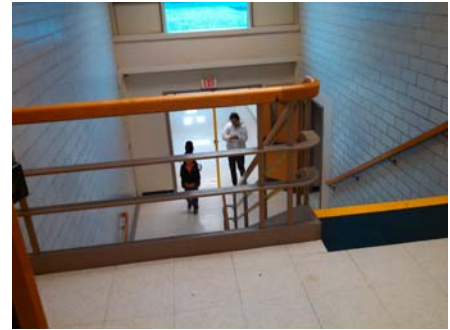
NON-COMPLIANT GUARD AND HANDRAILS

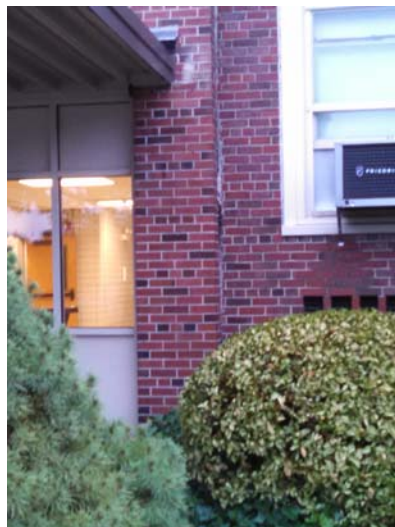
REPOINT BRICKS AT MAIN ENTRY

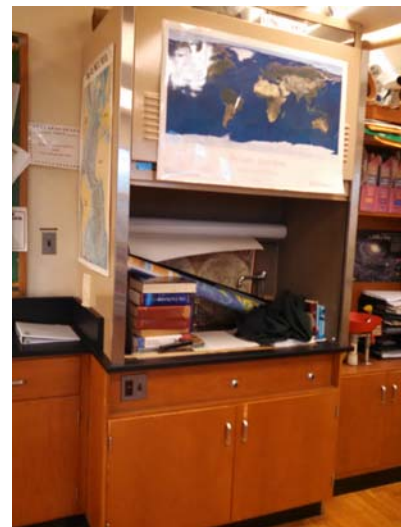
SCIENCE LAB CASEWORK IS WRONG FOR MS

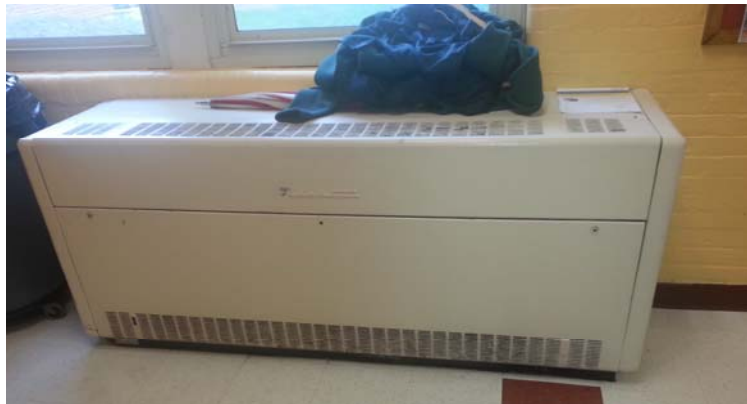
ORIGINAL HERMAN NELSON UNIT VENTILATOR

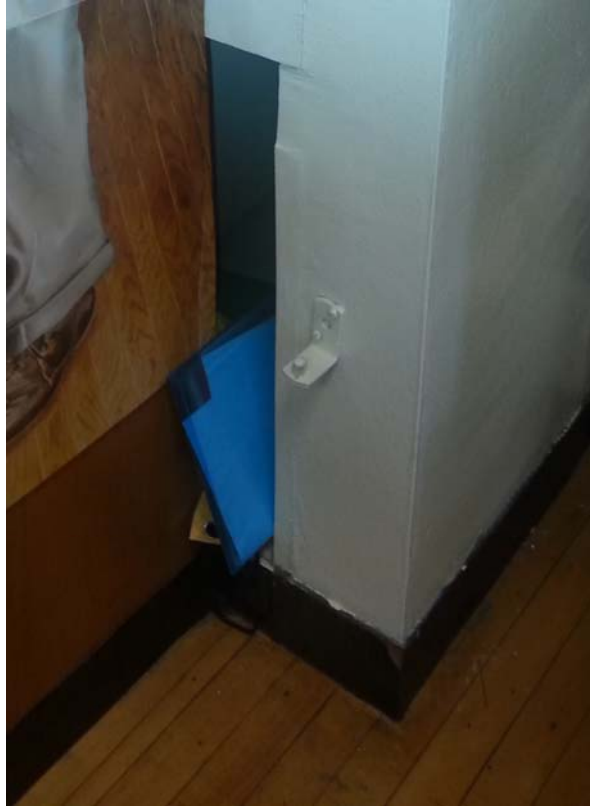
TYPICAL CLASSROOM VENTILATION EXHAUST OPENING ALMOST COMPLETELY BLOCKED BY A STORAGE CABINET.

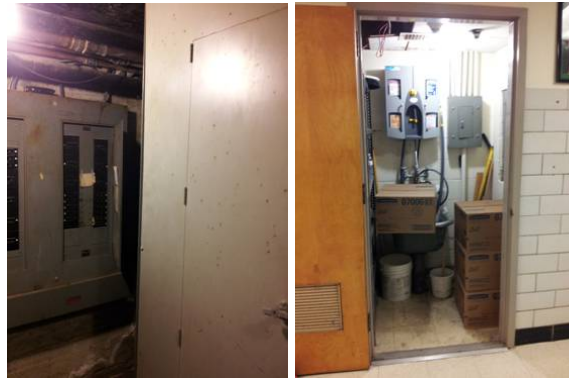
1. Majority of power distribution panels are old/beyond their life expectancy, and some panels became obsolete. A few panels (kitchen panels, janitor closet panels, gym panel) are installed in violation of the electrical code for clearances. Power feeders associated with “old” panels are beyond their life expectancy (fig 1).
2. Kitchen receptacles are non-GFCI type and have no GFCI protections (circuit breakers), which is not in compliance with the current electrical code (MEC), (fig 2).
3. Existing lighting control system does not comply with current energy code: although there are occupancy sensors in classrooms, the rest of lights are controlled by switches only (no occupancy sensors). Also, there are no daylight sensors in the building.

FIG 1: POWER DISTRIBUTION PANELS

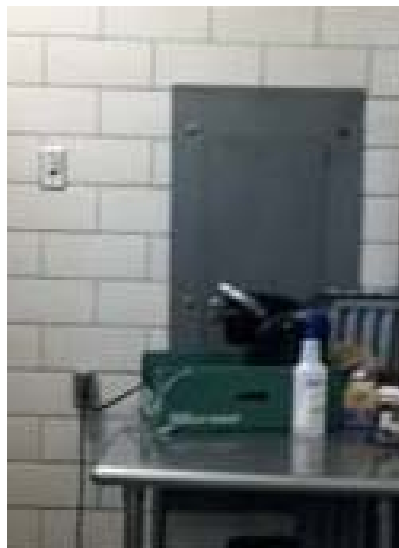
FIG 2: KITCHEN RECEPTACLES
