Phase V - Master Plan
Capital Needs Study

WESTWOOD PUBLIC SCHOOLS

Westwood, Massachusetts

June 17, 2015

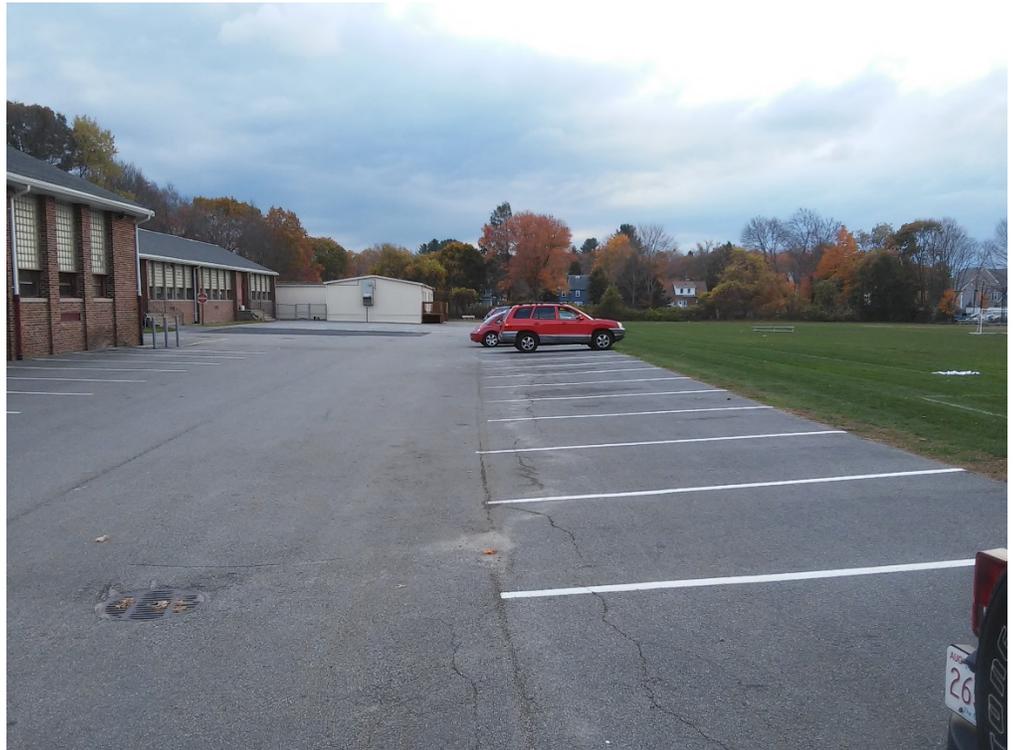
SEAM AND LONGITUDINAL CRACKING IN WEST PARKING LOT

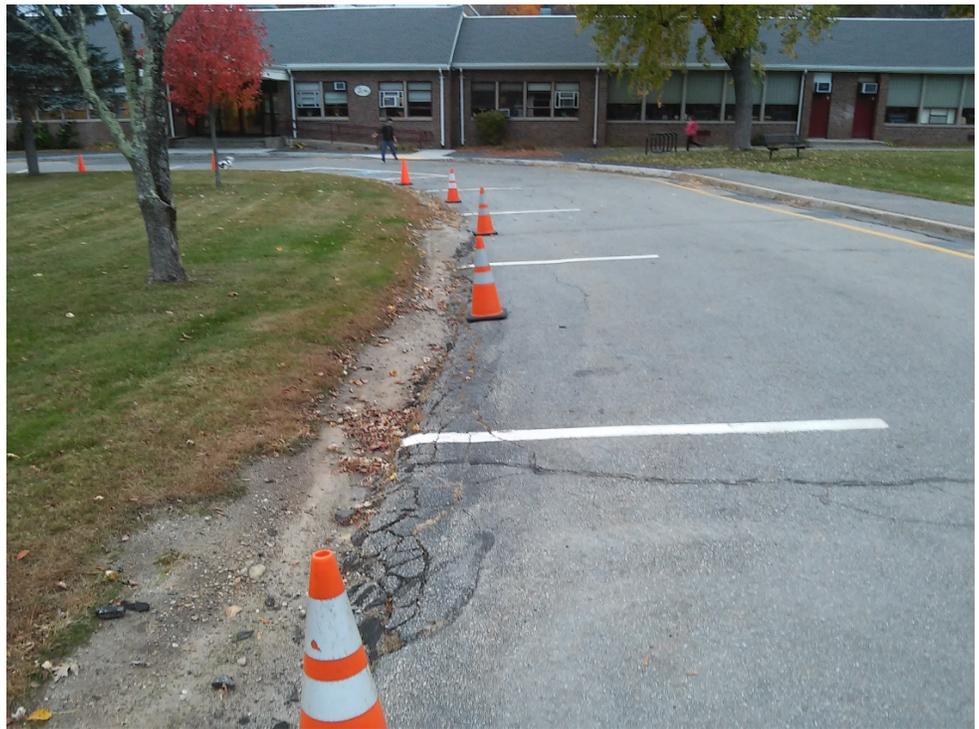
EDGE CRACKING AND ADJACENT RUTTING IN LANDSCAPE AREA AT FRONT BUS LOOP/PARKING AREA

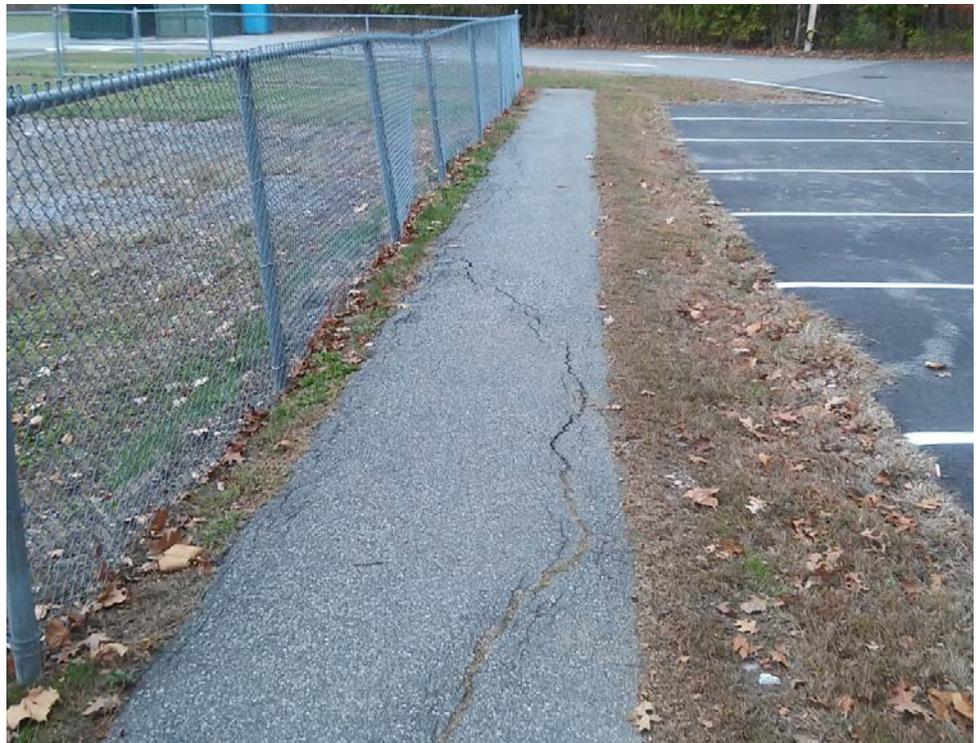
CRACKING AND HEAVING IN WALKWAY ADJACENT TO NORTHERN PARKING AREA

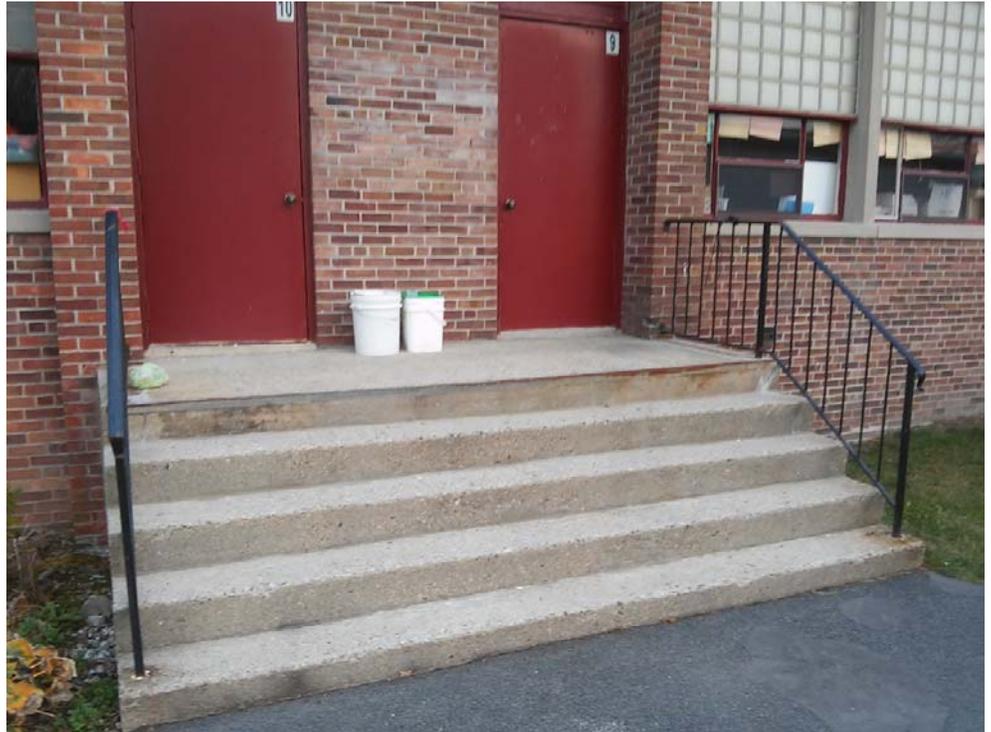
NON-ACCESSIBLE BUILDING EGRESS POINT ON WEST SIDE OF BUILDING

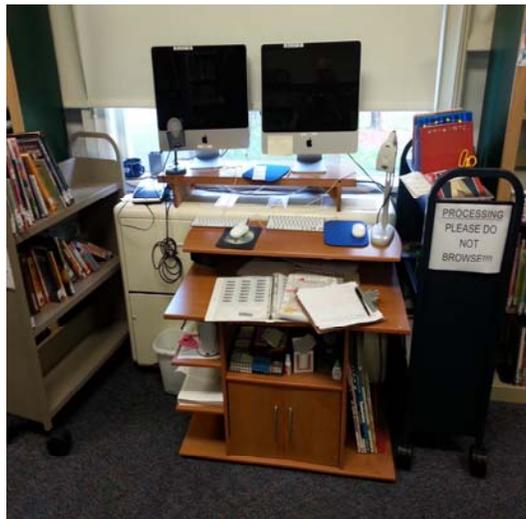
The classrooms each have an old Herman Nelson Unit Ventilator (UV) under the window. The rest of the exterior wall is covered with bookshelves which appear to have been hand built. The pneumatic controls are largely non-operational and the units typically run wild with the outdoor air damper and heating control valve both wide open. Lacking a functional thermostat teachers routinely turn the fan of the UV off when the room begins to overheat and back on as the room cools off. Steam traps may be under the unit or below in the tunnel. In the asbestos laden tunnel they are inaccessible but even when above the floor they have not been properly maintained and significant energy is lost as the steam blows by the traps.

MEDIA CENTER UNIT VENTILATOR. UVs ARE TYPICALLY NEARLY OBSCURED WITH FURNITURE, STACKED TEXTBOOKS AND OTHER TEACHING RESOURCES.

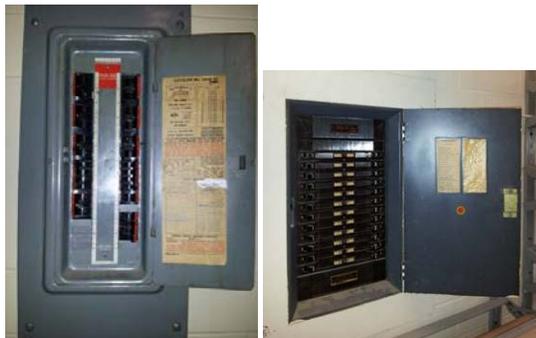
FIG 1: OLD PANELS

5. Existing lighting control system does not comply with current energy code: although there are occupancy sensors in classrooms and a few offices, the rest of lights are controlled by switches only (no occupancy sensors). Also, there are no daylight sensors in the building.

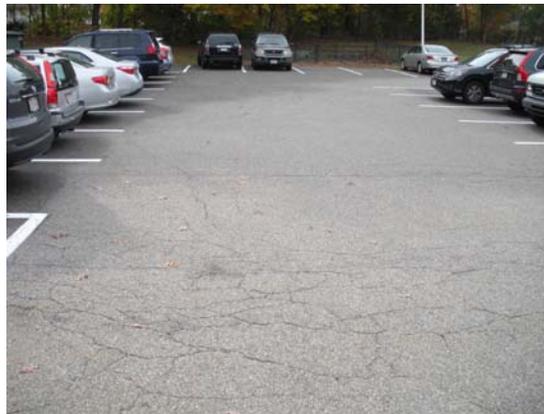
FATIGUE AND BLOCK CRACKING IN SOUTH PARKING LOT

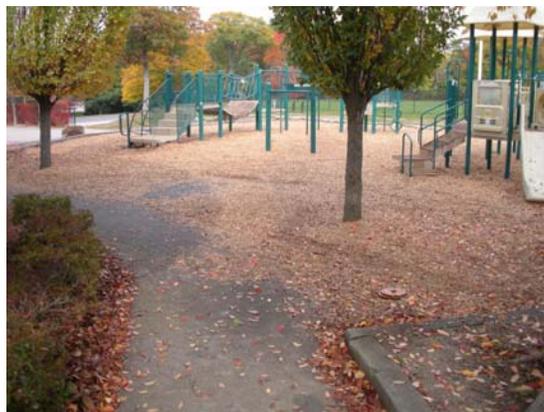
LACK OF ACCESSIBLE PATHS TO PLAY STRUCTURES

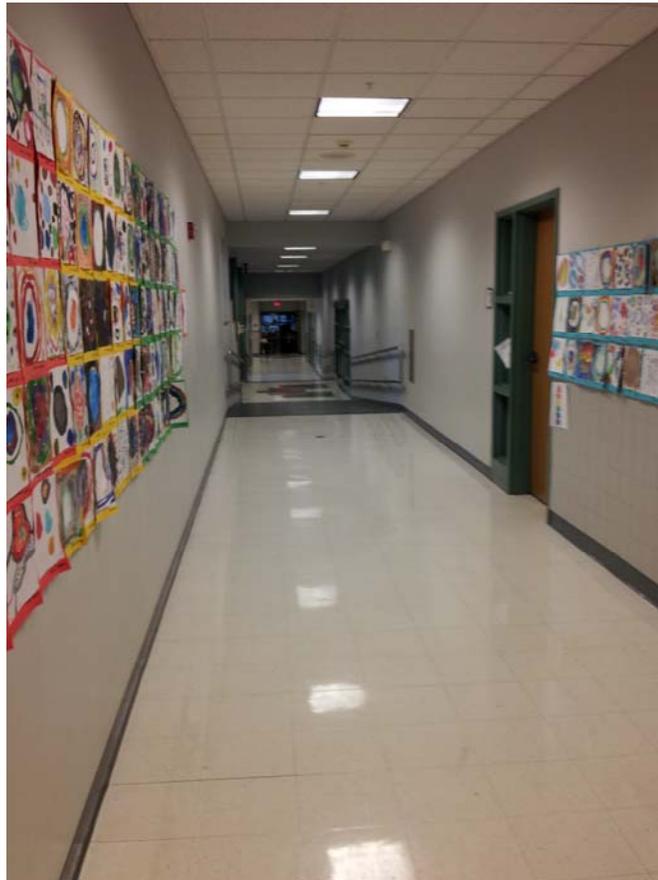
DRY ENVIRONMENT CONDITIONS CAUSE FLOOR AND CABINET PROBLEMS

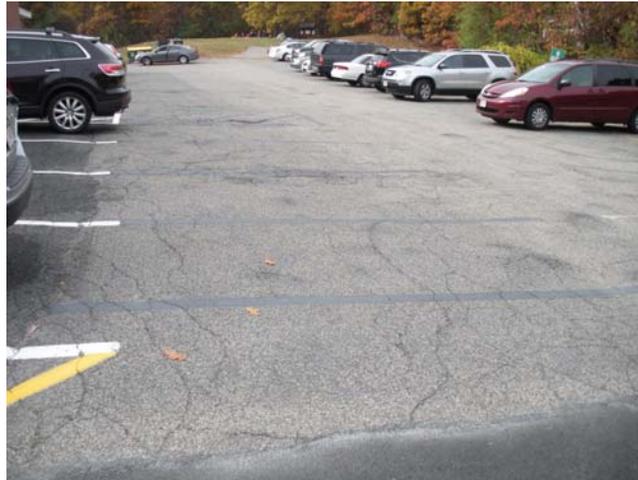
FATIGUE CRACKING AND HEAVING/SETTLEMENT IN NORTH PARKING LOT

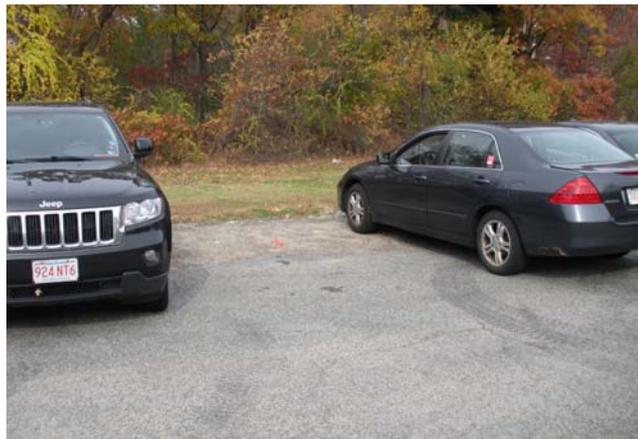
GRAVEL EXTENSION OF PARKING AREA WITH NO CURBING

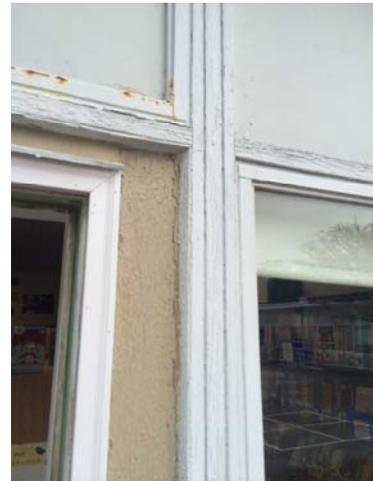
SINGLE GLAZED WINDOWS AND RUSTING STEEL FRAMES

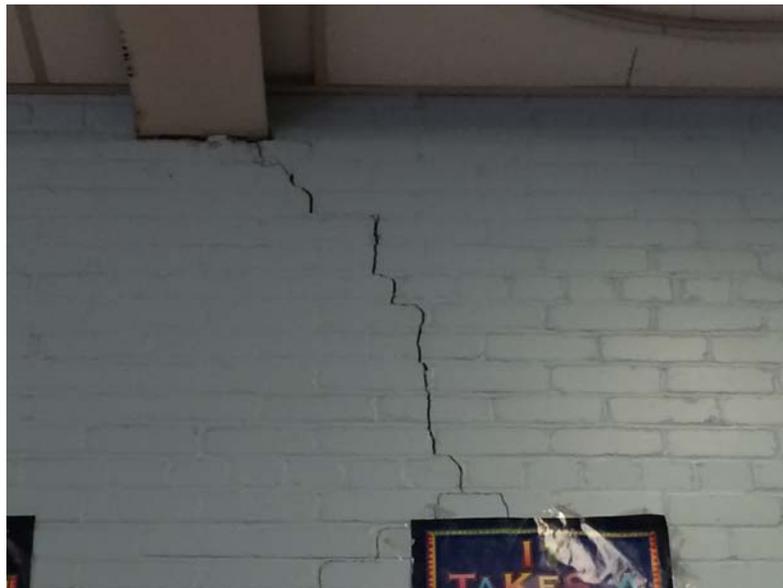
THE ORIGINAL LOAD BEARING BRICK WALLS IN THE ART ROOM (FORMERLY AND AUDITORIUM STAGE), ARE CRACKED BELOW WHERE A STEEL ROOF GIRDER BEARS ON THEM AT EACH END.

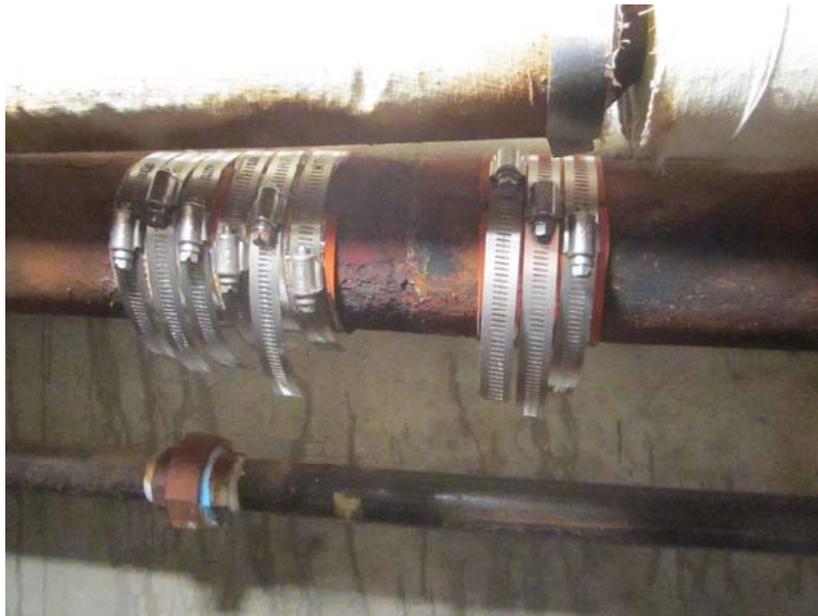
The condensate receiver and pumps are in fair condition. However the piping particularly the condensate is in critically poor condition with multiple leaks being repaired each year in areas that are accessible. Other leaks are occurring in more difficult to access locations and catastrophic failure is a distinct possibility.

PATCHED STEAM PIPING. THE SMALLER DIAMETER CONDENSATE PIPE HAS BEEN REPLACED TO THE RIGHT OF THE UNION (JOINT).

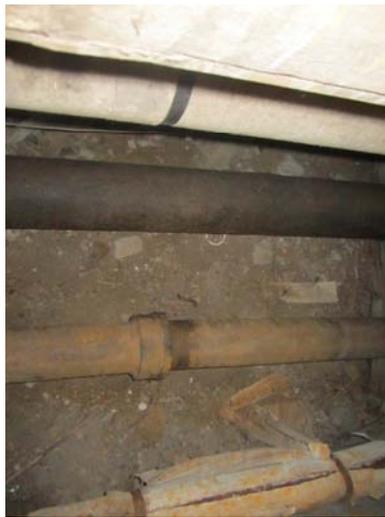
Both of these products are asbestos containing. The insulation, where visible, is in poor condition often due to having been saturated by steam or condensate leaking from the decayed piping. Asbestos laden insulation materials are visible on the sand floor of the tunnels. The tunnels have hatches in many of the classrooms but must be considered confined spaces.

LOOKING DOWN INTO THE STEAM TUNNEL FROM A CLASSROOM HATCH. NOTICE THE DAMAGED ASBESTOS PIPE INSULATION AND DEBRIS ON THE FLOOR.

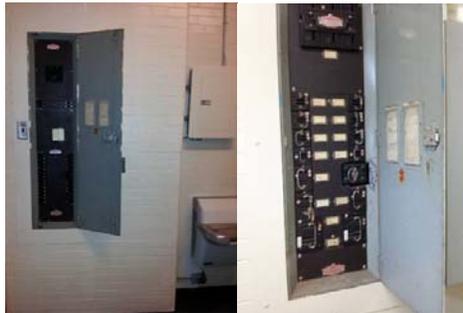
FIG 1: OLD PANELS

6. Existing lighting control system does not comply with current energy code: although there are occupancy sensors in classrooms and a few offices, the rest of lights are controlled by switches only (no occupancy sensors). Also, there are no daylight sensors in the building.

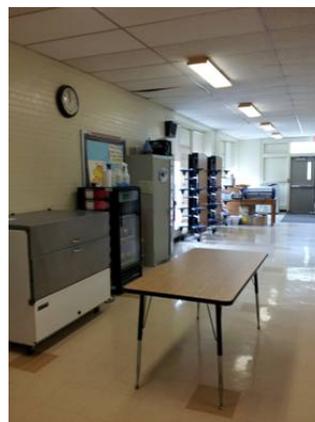
FIG 3: INADEQUATE LIGHTING LEVELS

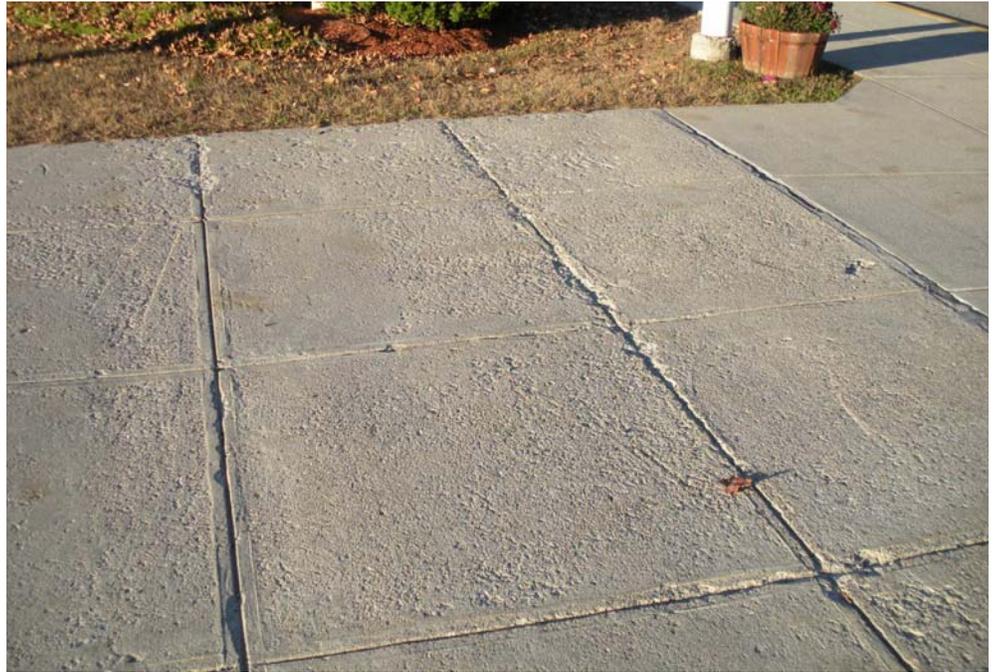
CONCRETE DETERIORATION IN PLAZA/WALKWAY NEAR FRONT ENTRANCE

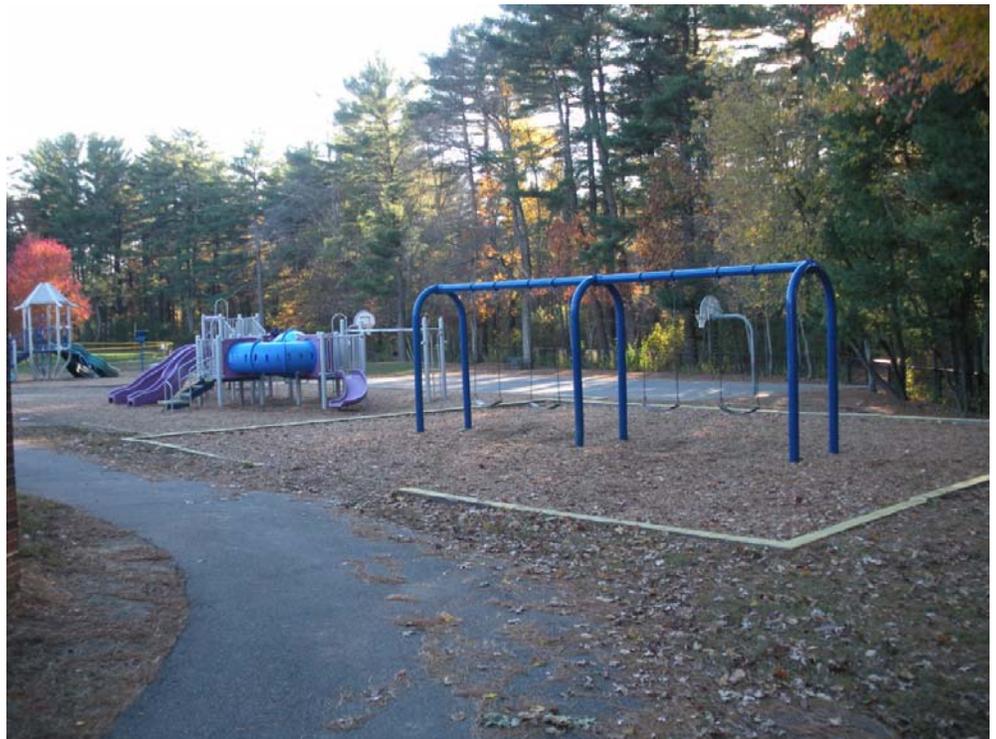
LACK OF ACCESSIBLE PATHS TO PLAY STRUCTURES

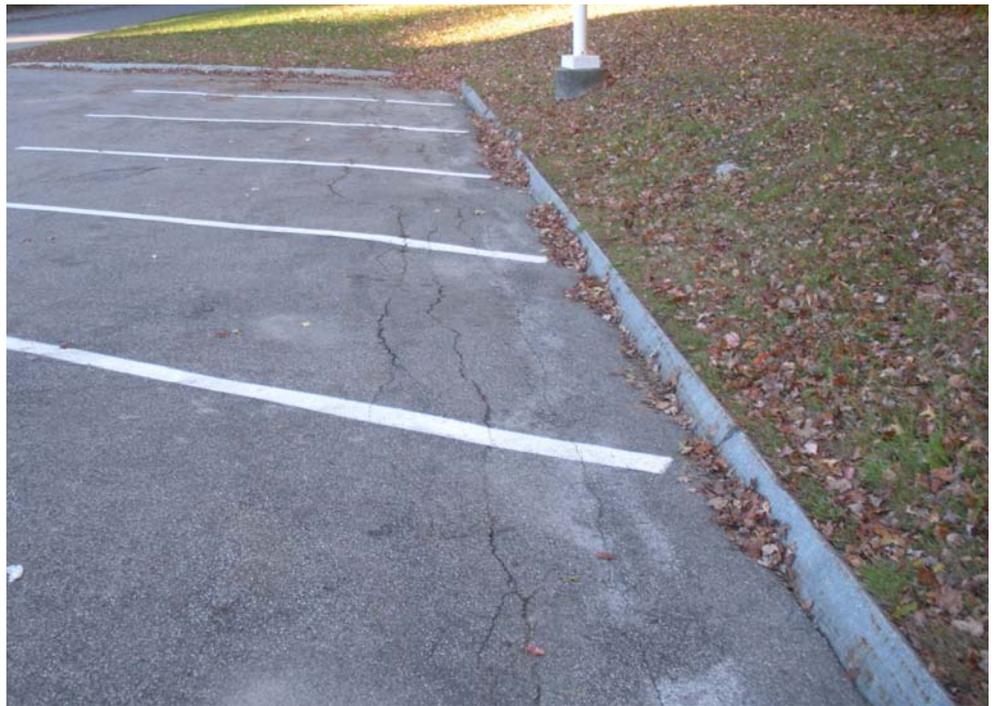
FATIGUE CRACKING AND SETTLEMENT ALONG EDGE OF EAST PARKING LOT

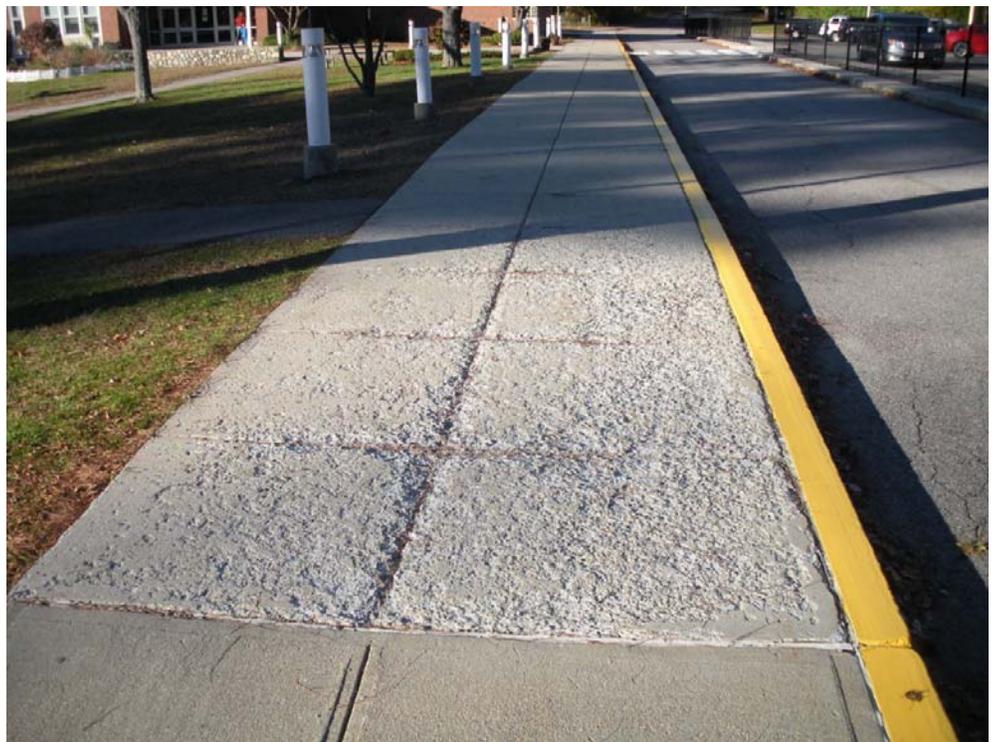
CONCRETE DETERIORATION AT WALKWAY ADJACENT TO BUS LANE

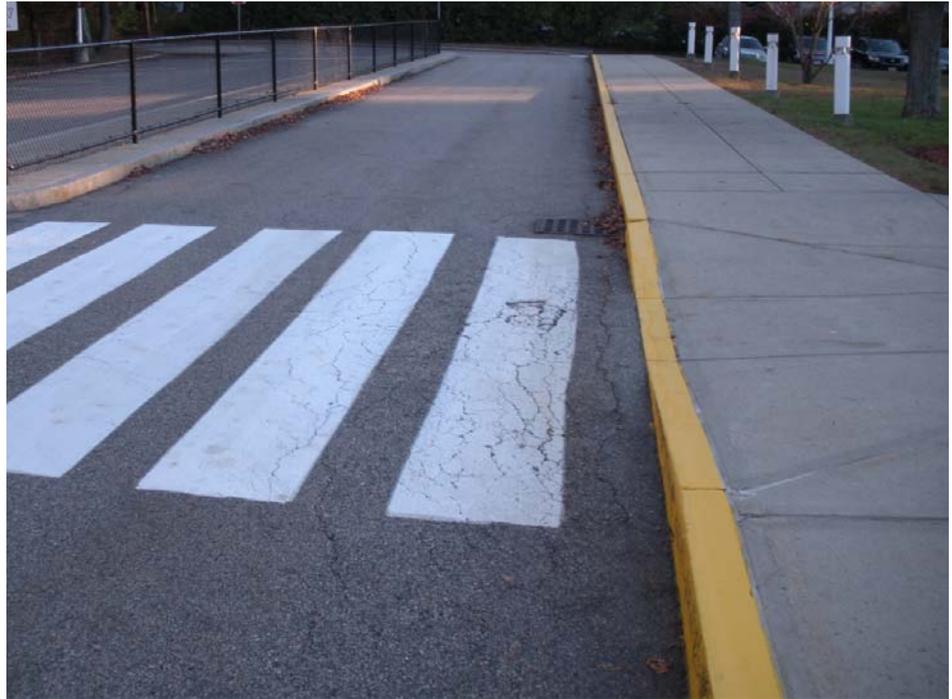
LACK OF DETECTABLE WARNING PANEL AT BUS LOOP CURB CUT, AND PAVEMENT CRACKING

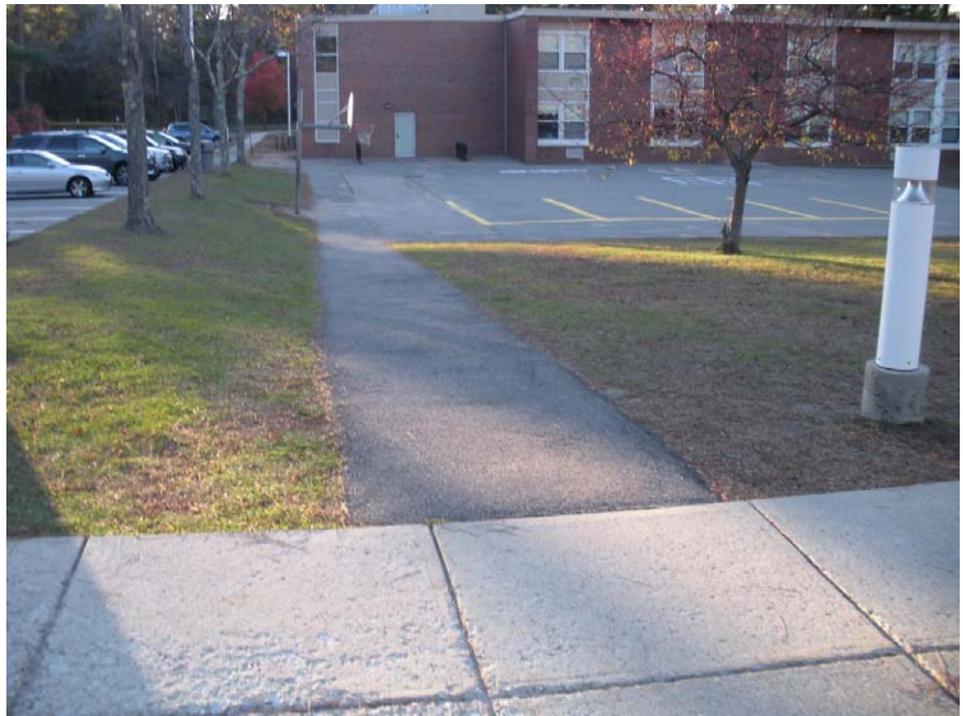
WALKWAY TO BITUMINOUS PLAY AREA/BASKETBALL COURT EXCEEDS MAAB SLOPE REQUIREMENTS

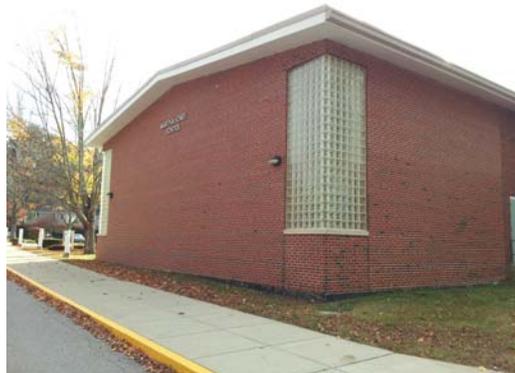
A FEW HAIRLINE CRACKS IN GLASS BLOCK MORTAR JOINTS

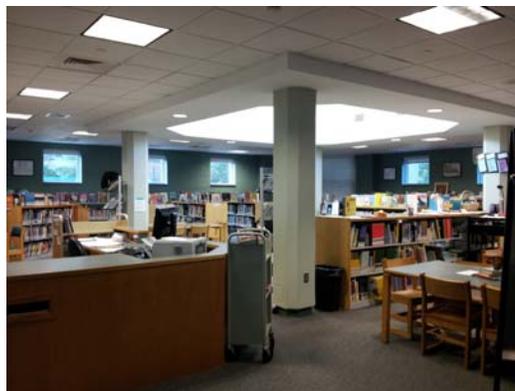
ROOF LEAKS AT MONITOR IN THE LIBRARY

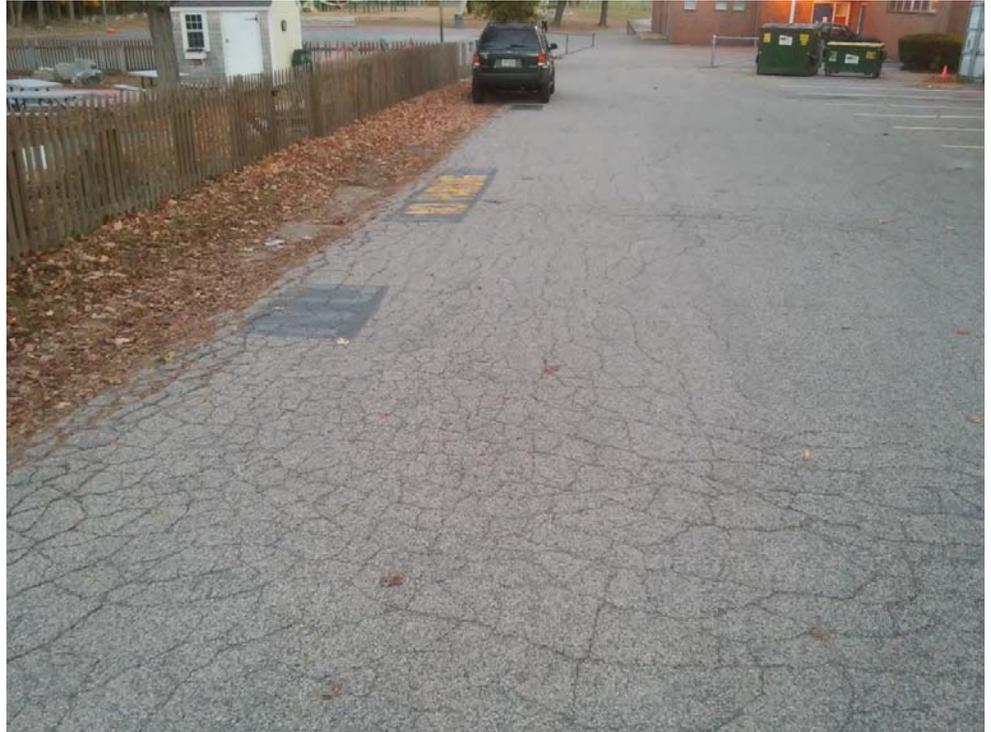
FATIGUE CRACKING IN NORTHWEST PARKING AREA/ACCESS DRIVE

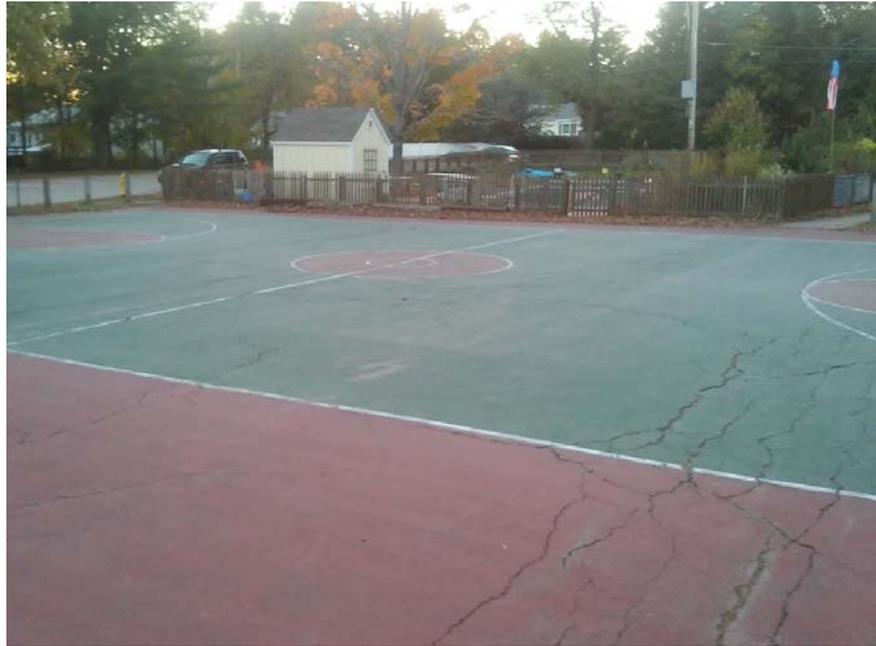
FATIGUE AND TRANSVERSE CRACKING AT BASKETBALL COURTS

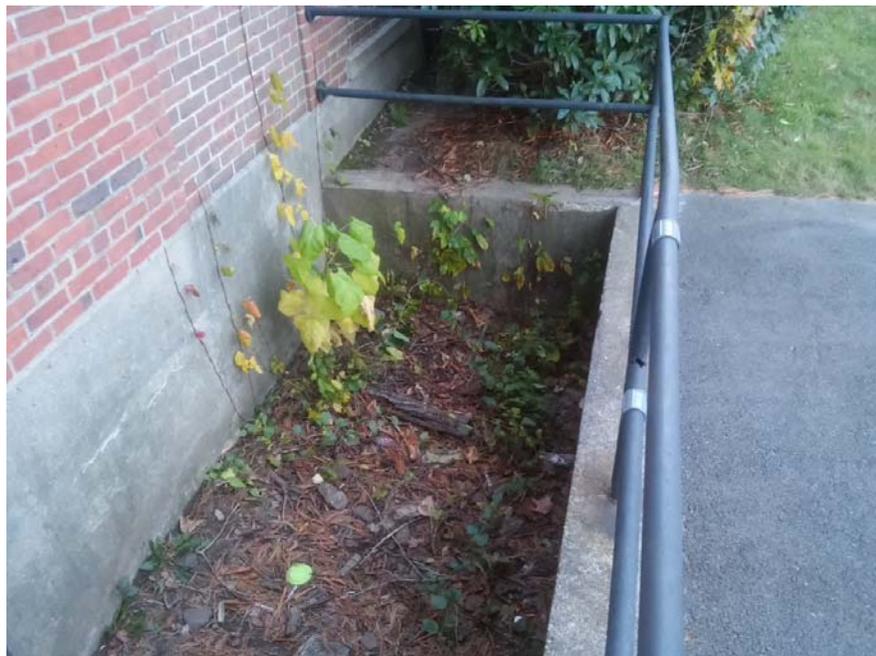
LOWER LEVEL PIT/EGRESS AT BOILER ROOM CLOGGED WITH DEBRIS AND VEGETATION

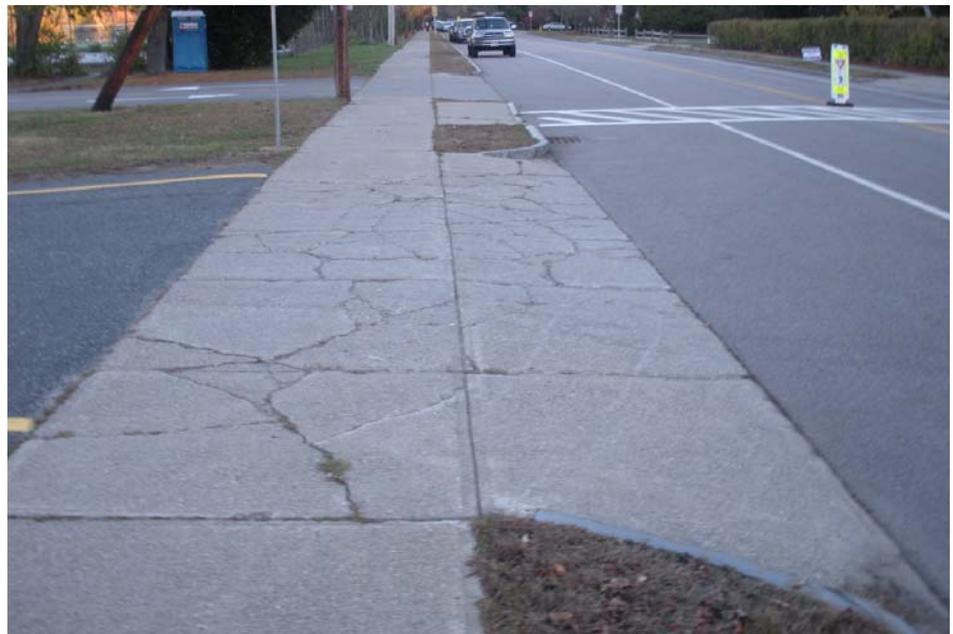
BLOCK AND FATIGUE CRACKING AT CONCRETE ENTRANCE APRONS

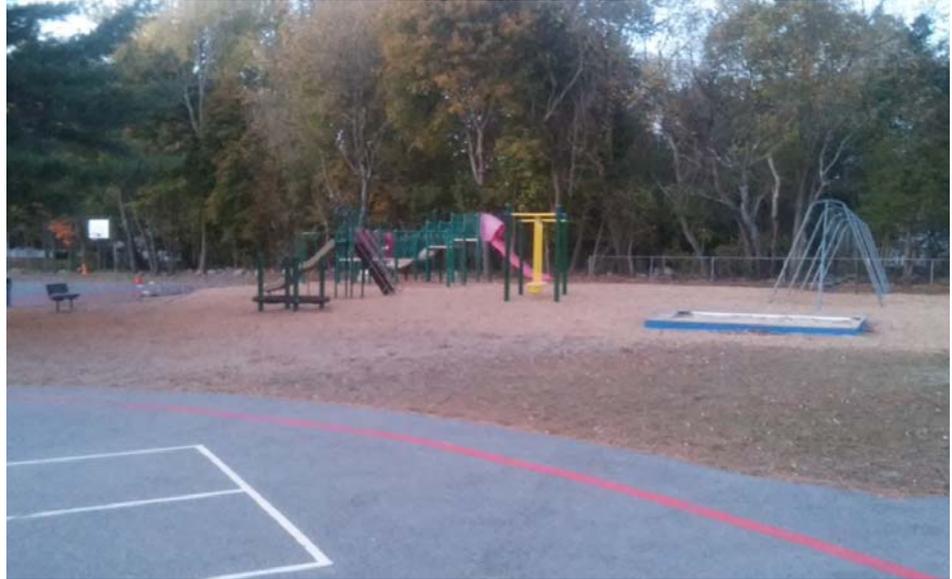
NO ACCESSIBLE ROUTES PROVIDED TO THE WOOD-FIBER PLAY AREA AND STRUCTURES

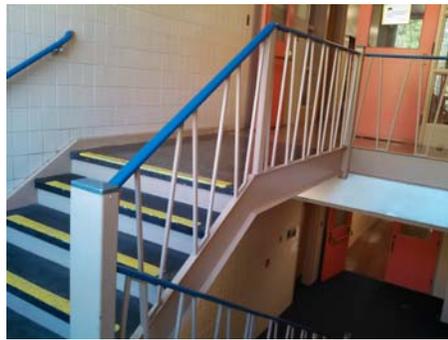
NON-COMPLIANT STAIR GUARD AND HAND RAILS

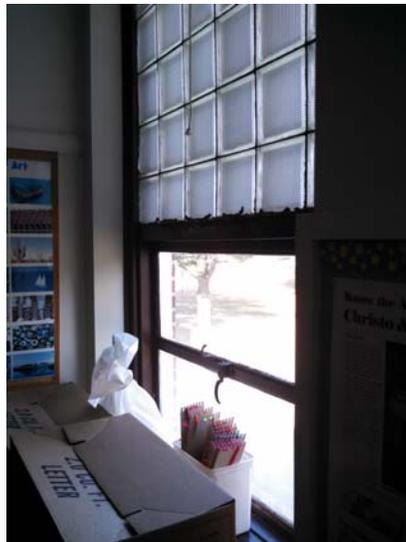
RUSTING STEEL FRAME WINDOWS IN GLASS BLOCK

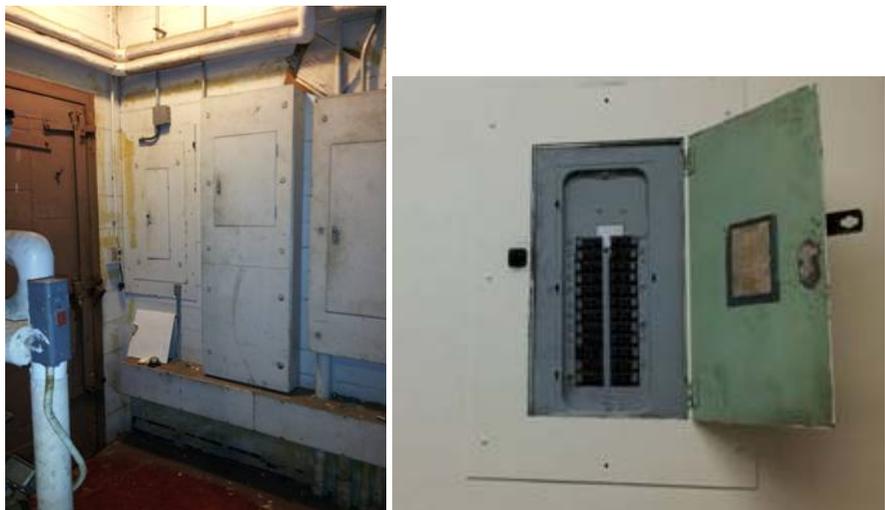
FIG 1: OLD PANELS

7. Existing lighting control system does not comply with current energy code: there are no occupancy sensors or programmable lighting control system, and there are no daylight sensors either.

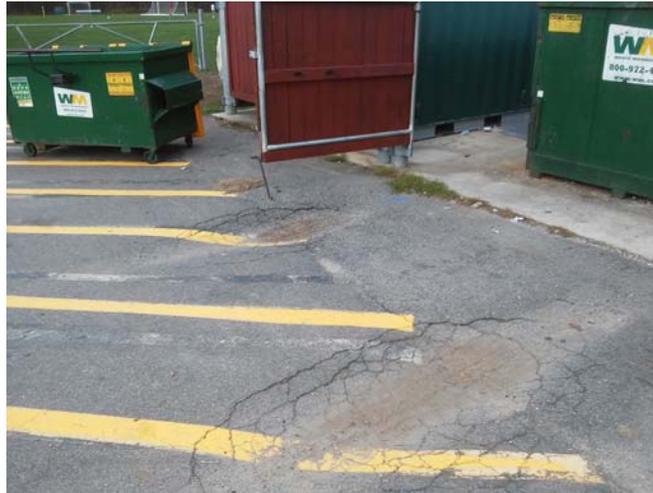
PAVEMENT RUTTING AT DUMPSTER AREA

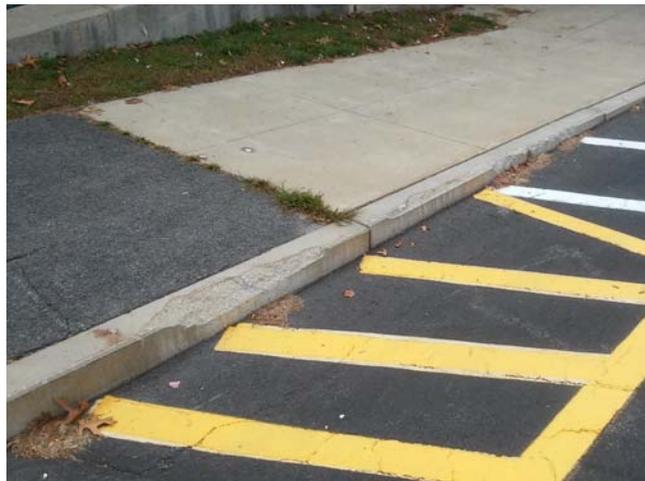
CONCRETE CURB DAMAGE/DETERIORATION NEAR NORTHEAST ENTRANCE

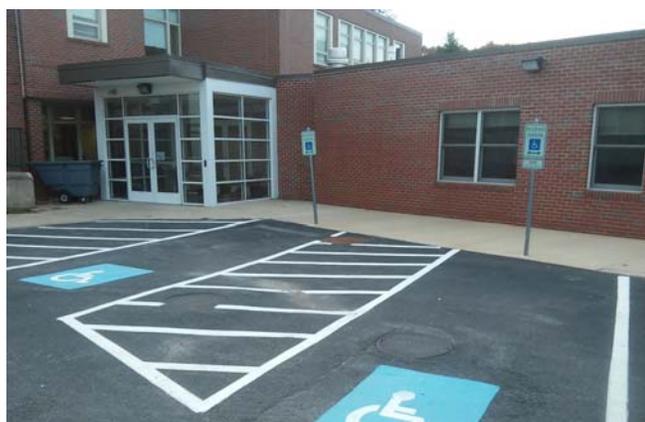
LACK OF CURBING, WHEELSTOPS AND BOLLARDS AT NORTHEAST ENTRANCE

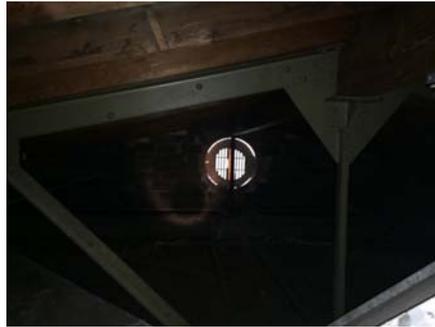
ATTIC LOUVER LEAK

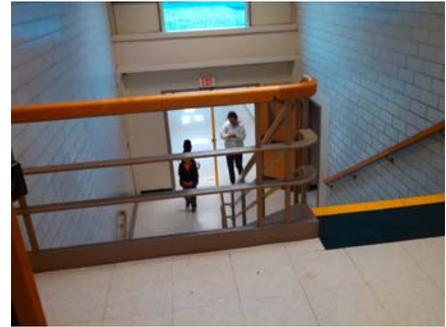
NON-COMPLIANT GUARD AND HANDRAILS

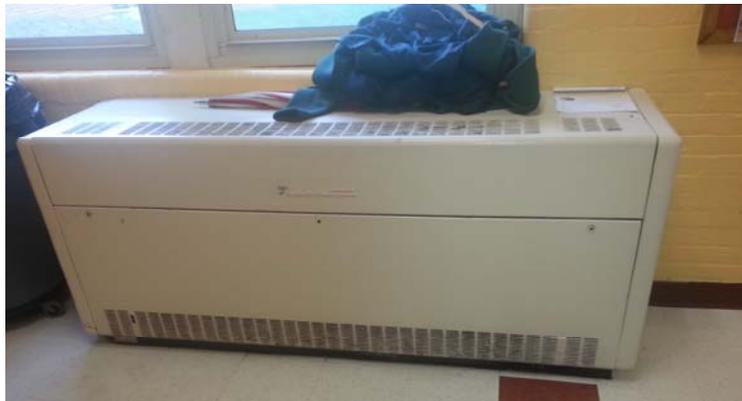
ORIGINAL HERMAN NELSON UNIT VENTILATOR

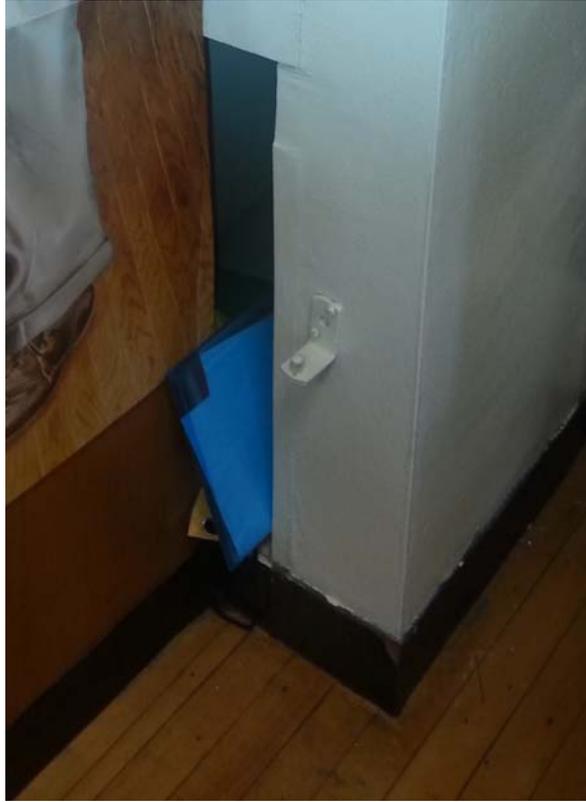
TYPICAL CLASSROOM VENTILATION EXHAUST OPENING ALMOST COMPLETELY BLOCKED BY A STORAGE CABINET.
