# Westwood Public Schools Master Plan

# ASSESSING EXISTING CONDITIONS

# Assessment: Existing Conditions

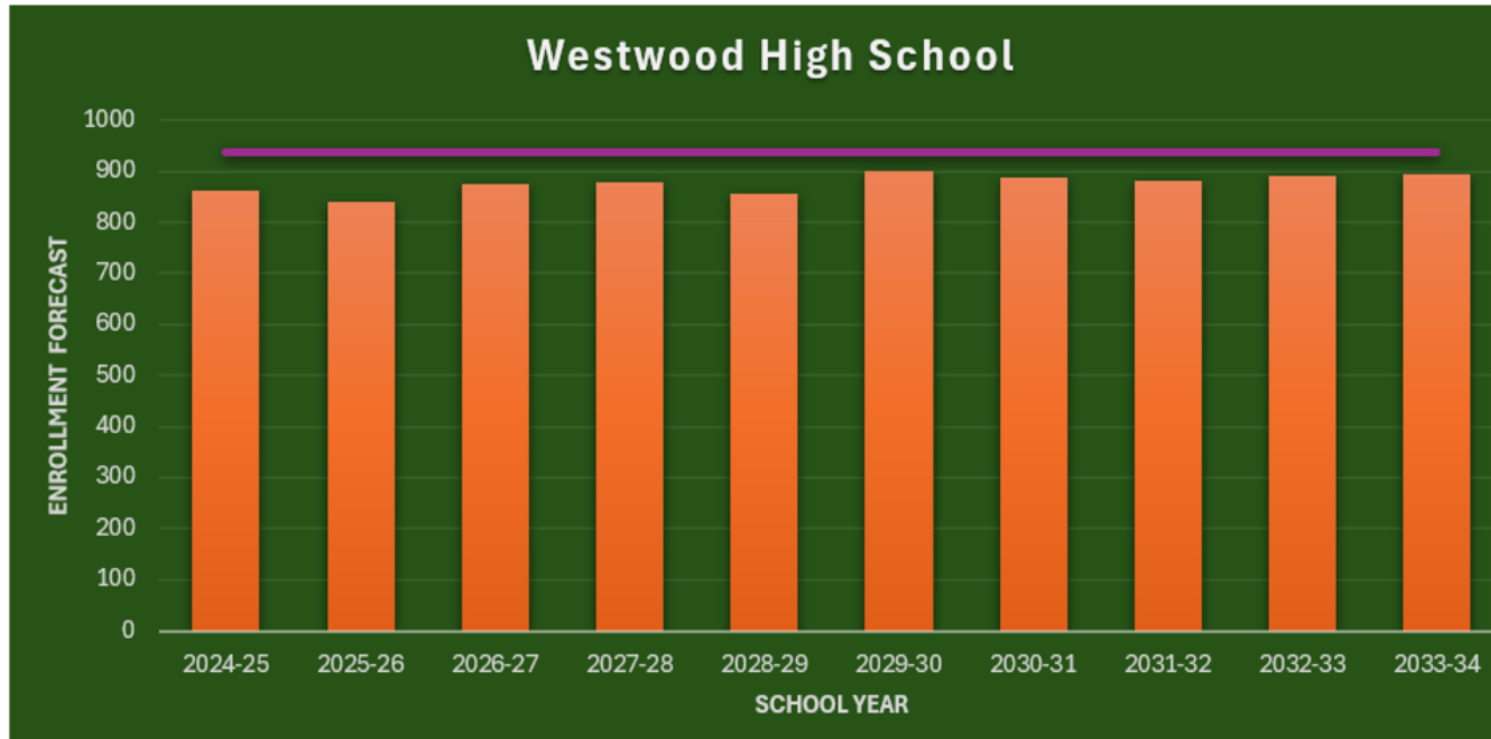
## Westwood High School

- **Capacity:** 938 students
- **Peak enrollment:** 902 students

The enrollment forecasts a stable number of students through 2033.

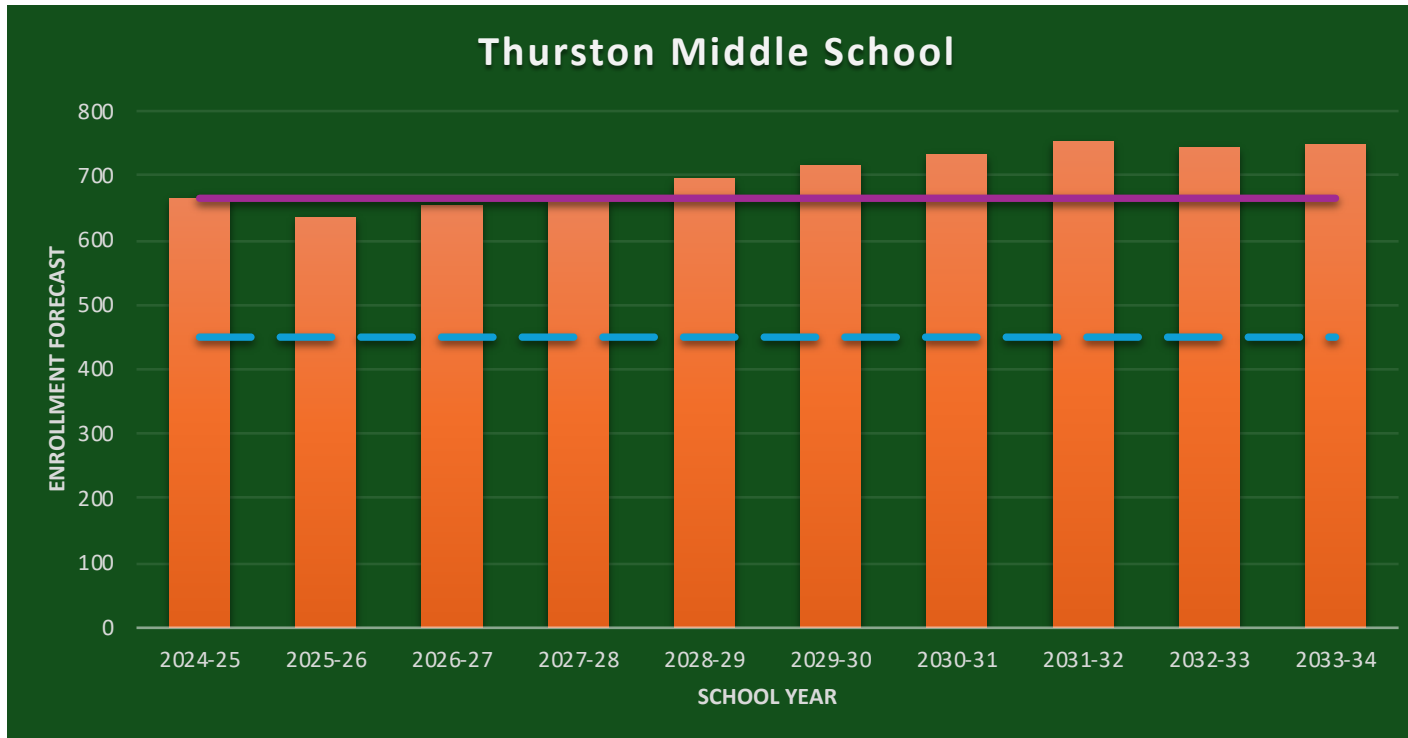
## Thurston Middle School

- **Capacity with modulators:** 665 students (red line)
- **Capacity without modulators:** 450 students (blue line)
- **2031 peak:** 753 (26 students/classroom)
- **2033 enrollment:** 748 students

By 2033, 5 additional classrooms will be needed to maintain average of 23 students per classroom.

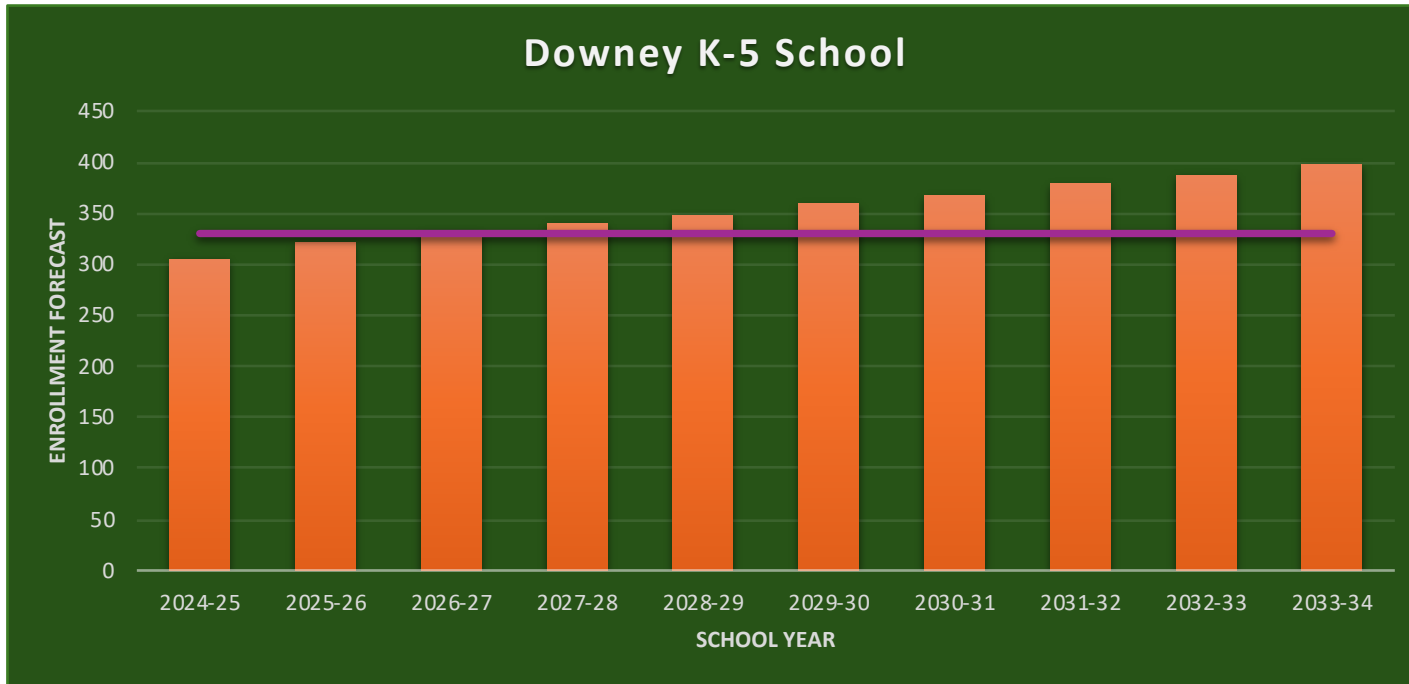
## Downey School

- **Capacity:** 330 students
- **2029:** 20/classroom (kindergarten)
- **2029:** 25/classroom (grades 1-5)
- **2033 enrollment:** 398 students

By 2033, 1 additional kindergarten and 2 additional 1-5 classrooms will be needed.

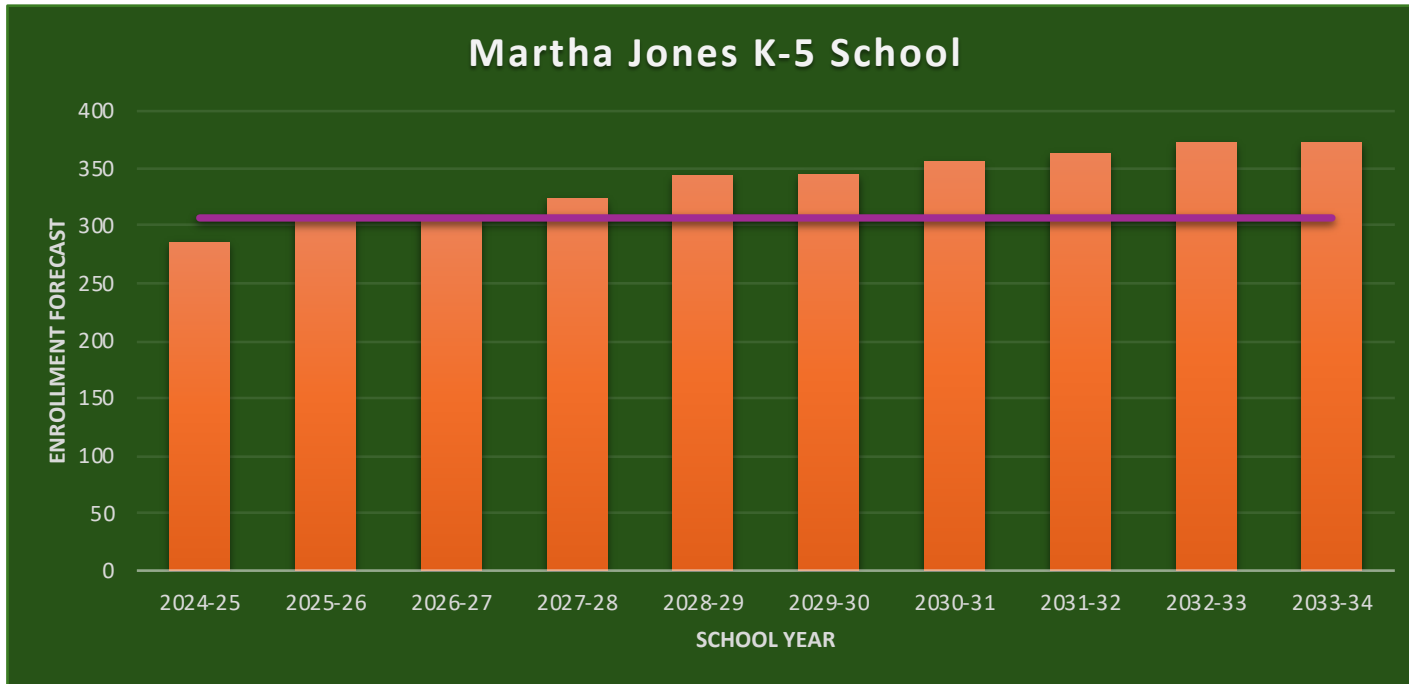
## Martha Jones School

- **Capacity:** 307 students
- **2028:** 26/classroom (grades 1-5)
- **2033 enrollment:** 373 students

By 2033, 3 additional 1-5 classrooms will be needed. No additional K classrooms are needed.

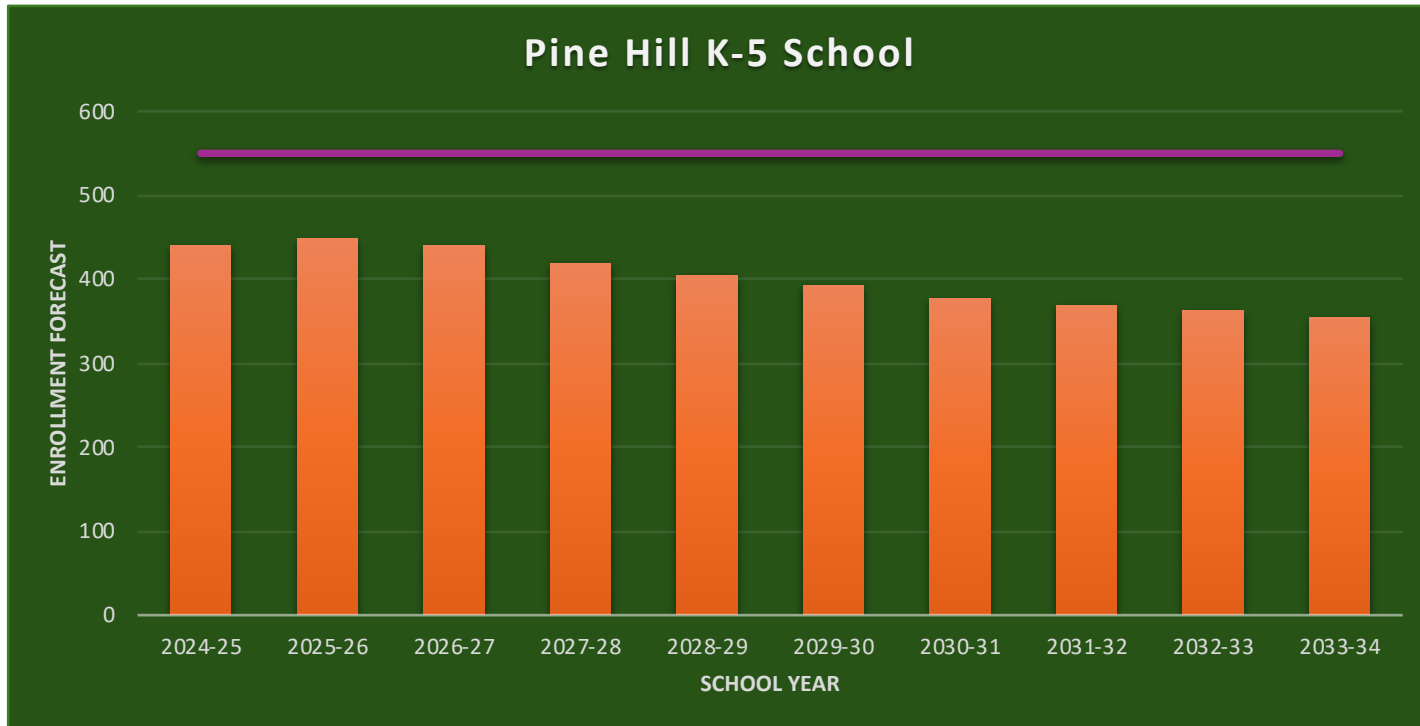
## Pine Hill School

- **Capacity:** 550 students
- **2033 enrollment:** 355 students

The enrollment forecasts a decreasing number of students in the current Pine Hill district.

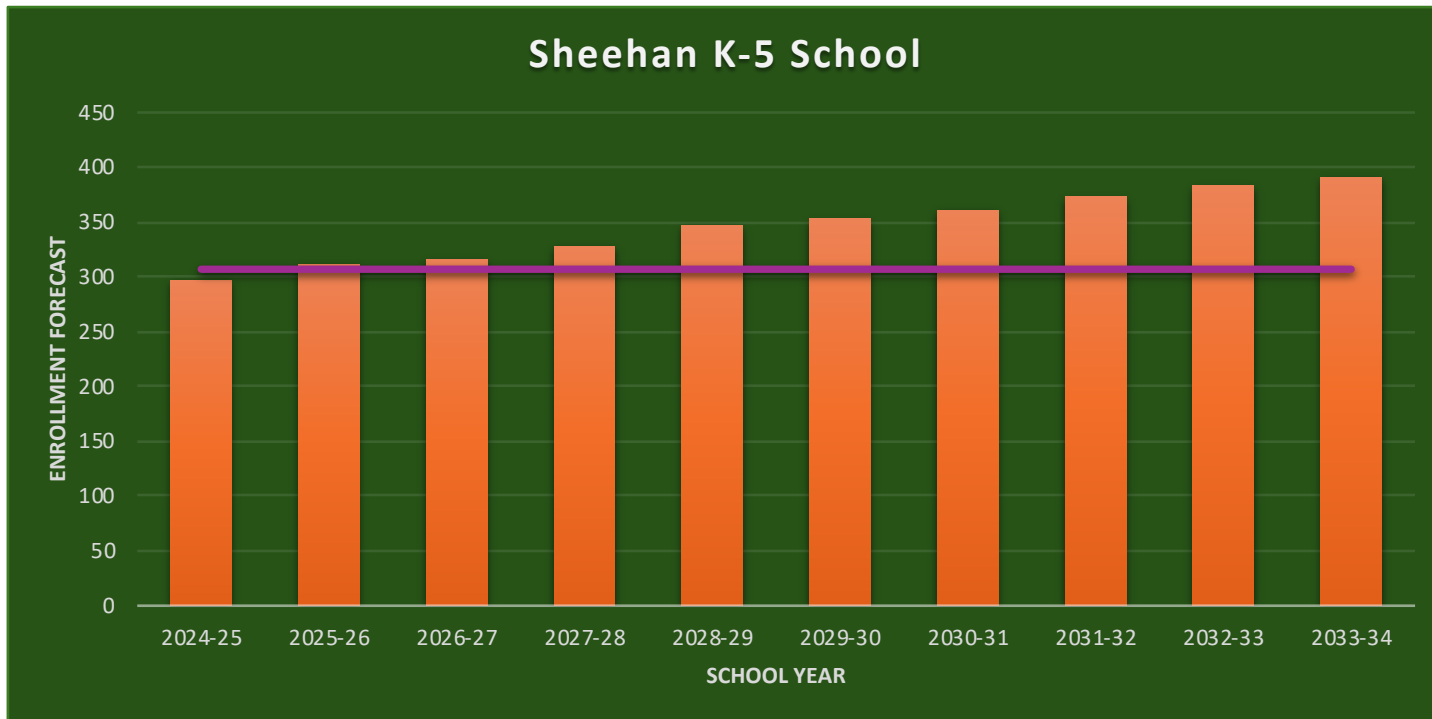
## Sheehan School

- **Capacity:** 330 students
- **2030:** 20/classroom (kindergarten)
- **2033 enrollment:** 391 students

By 2033, 1 additional kindergarten and 1 additional 1-5 classroom will be needed.

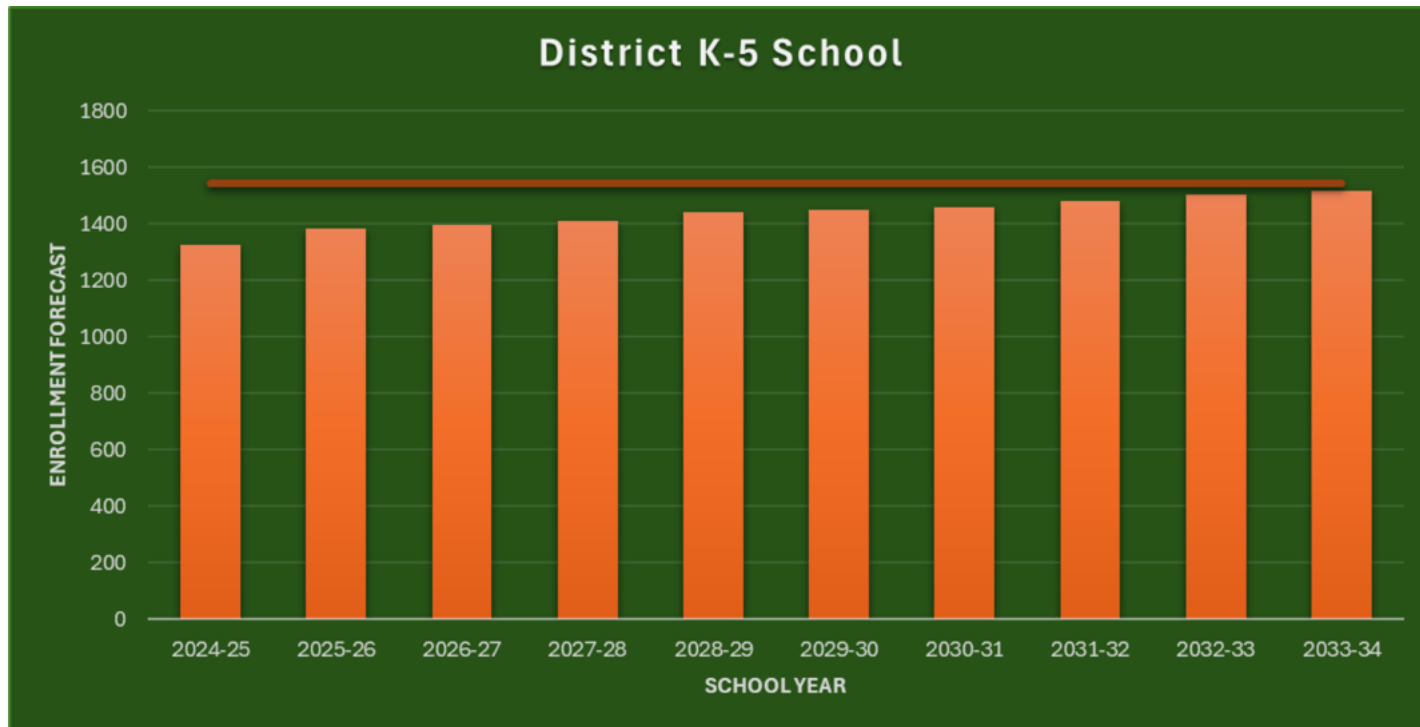
## District-wide Elementary Schools

- **Capacity:** 1540 students
- **Capacity grades 1-5:** 1288
- **2033:** 237 (kindergarteners)
- **2033:** 1278 (grades 1-5)
- **2033 enrollment:** 1517 students

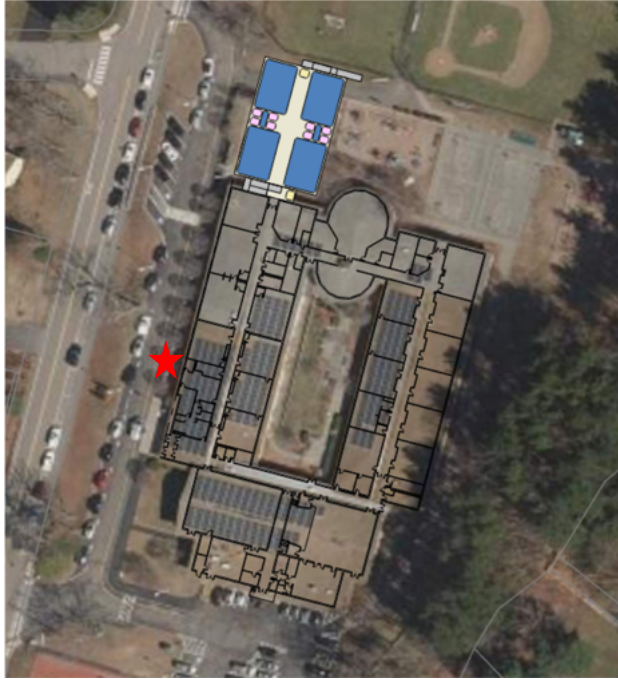
## **Downey:**

4 modular classrooms with restrooms and small group/special education spaces.

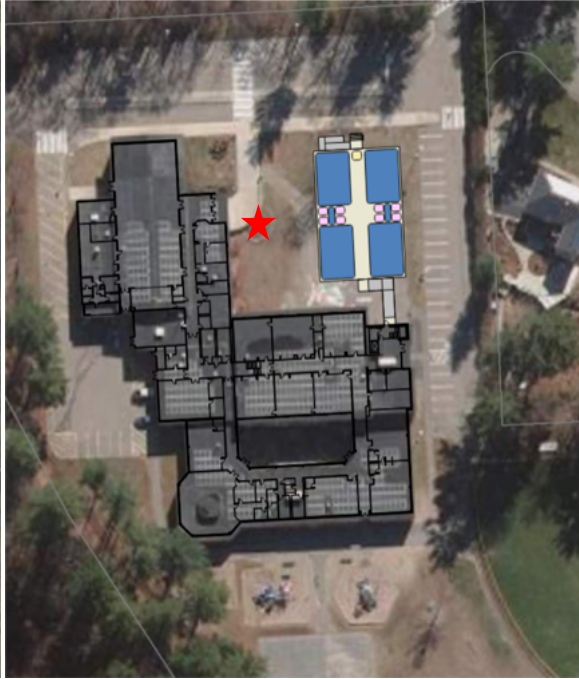
## **Martha Jones:**

4 modular classrooms with restrooms and small group/special education spaces.

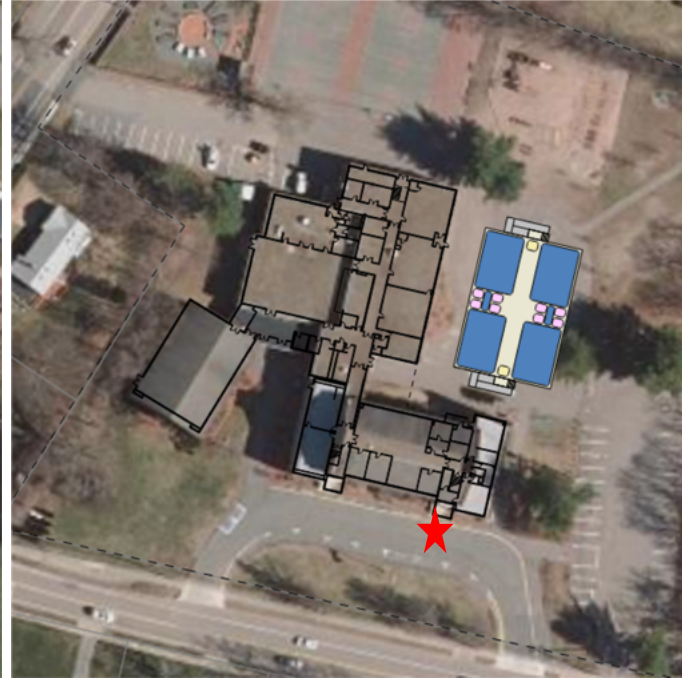
## **Sheehan:**

4 modular classrooms with restrooms and small group/special education spaces.

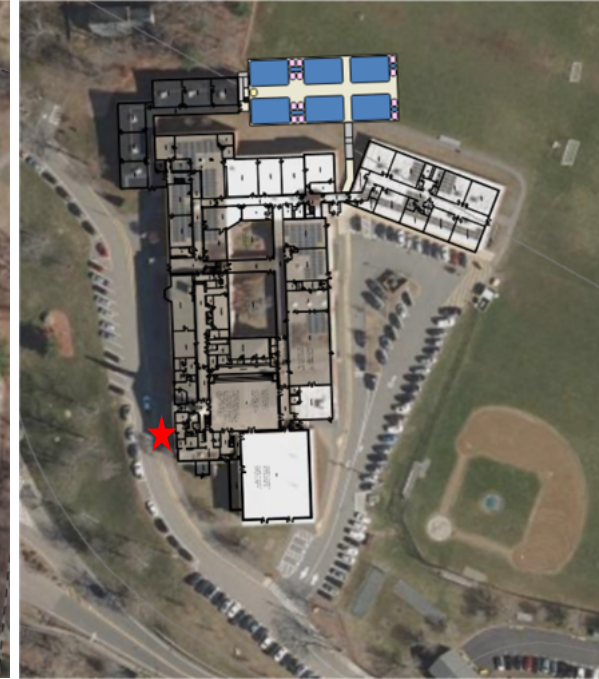
## **Thurston:**

6 modular classrooms with restrooms, small group, and 1 special education classroom.

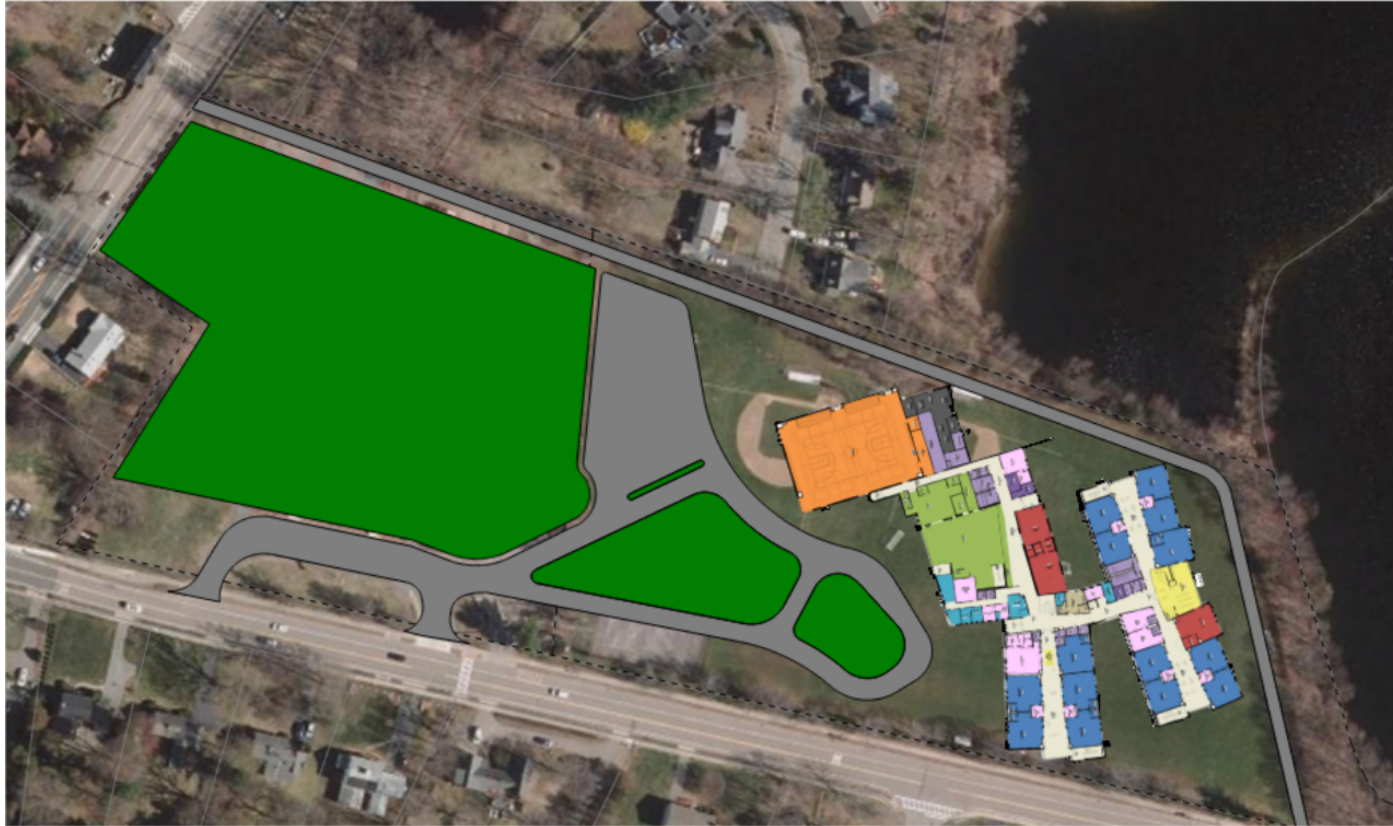
## **Test Fit:**

New K-5 School on Sheehan site
