Phase V - Master Plan
Capital Needs Study

WESTWOOD PUBLIC SCHOOLS

Westwood, Massachusetts

June 17, 2015

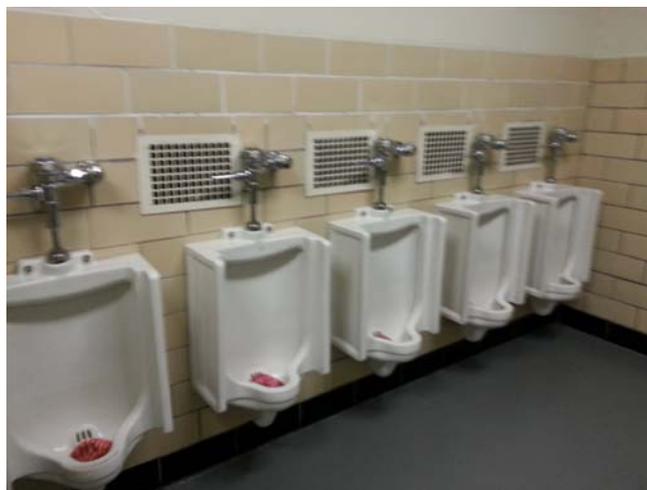
NO PRIVACY SCREENS AT URINALS

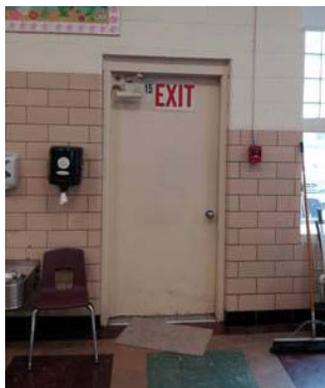
FIG 2: PRINTED EXIT SIGN

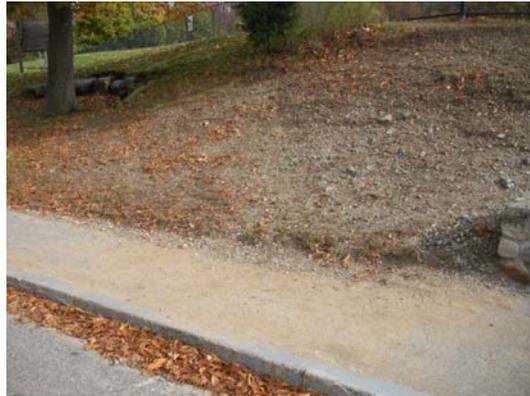
EROSION OF STEEP SLOPE ADJACENT TO PLAYFIELDS

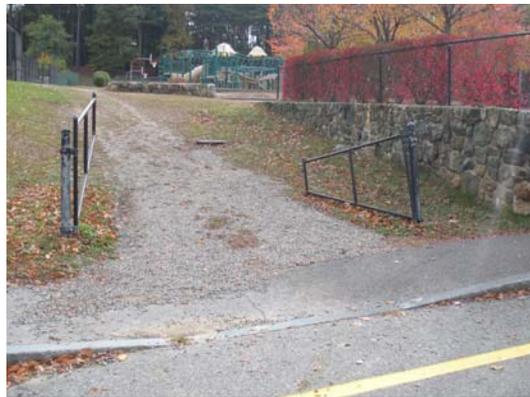
ERODED GRAVEL ACCESS PATH TO GRASS PLAYFIELDS; LACK OF DETECTABLE WARNING PANELS

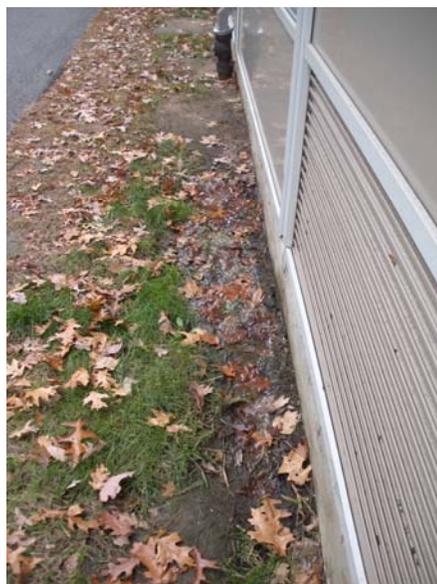
STANDING WATER ALONG BACK (WEST) SIDE OF BUILDING

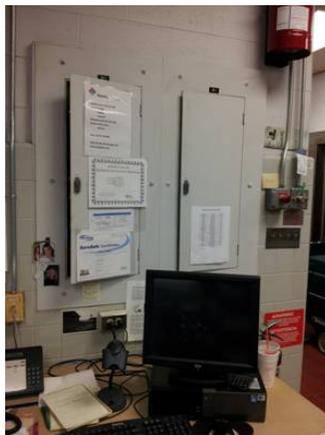
1. Kitchen panel is old/beyond its life expectancy. Power feeder associated with this panel is beyond its life expectancy (fig 1).
2. Kitchen receptacles are non-GFCI type and have no GFCI protections (circuit breakers), which is not in compliance with the current electrical code (MEC), (fig 2).
3. Existing lighting control system does not comply with the current energy code: there are no occupancy sensors, no daylight sensors, and no programmable lighting control system for interior lights.

FIG 1: OLD PANELS

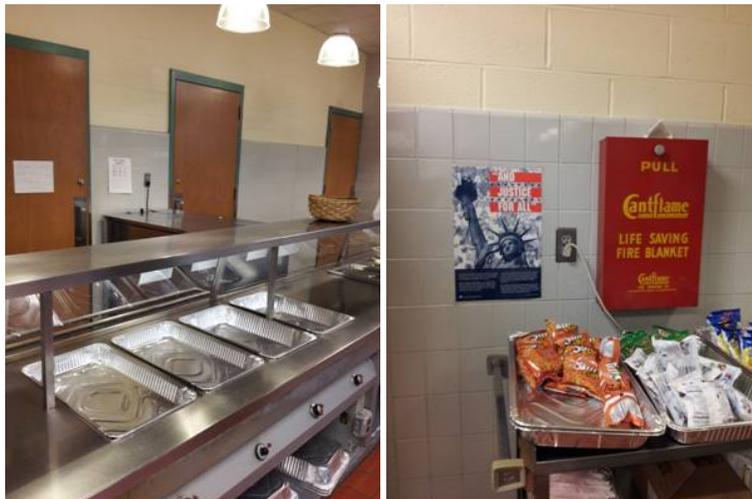
FIG 2: KITCHEN RECEPTACLES

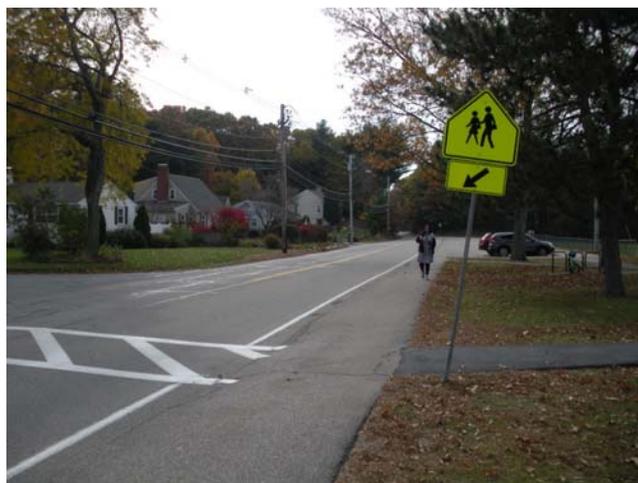
LACK OF DETECTABLE WARNING PANEL AT CURB CUT ONTO GAY STREET

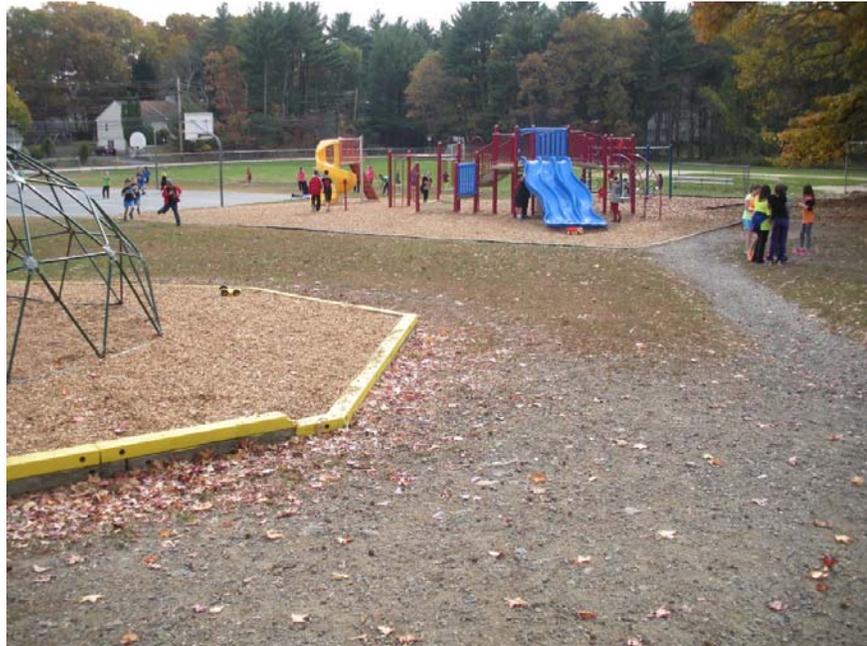
LACK OF ACCESSIBLE PATH TO SOME PLAY AREAS AND STRUCTURES

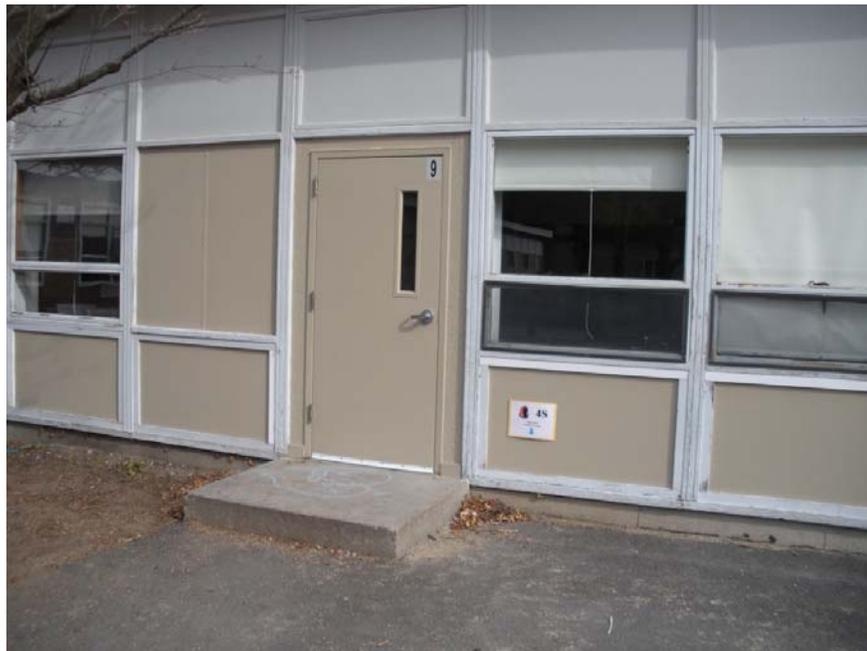
NON-ACCESSIBLE BUILDING EGRESS ON SOUTH SIDE OF BUILDING

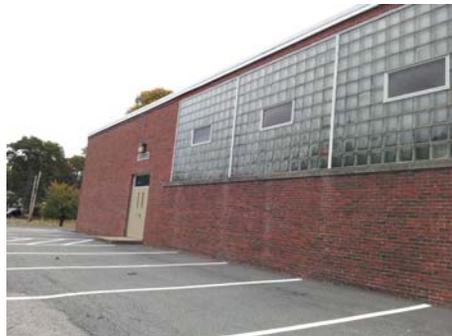
BRICK AND GLASS BLOCK REPOINTING REQUIRED

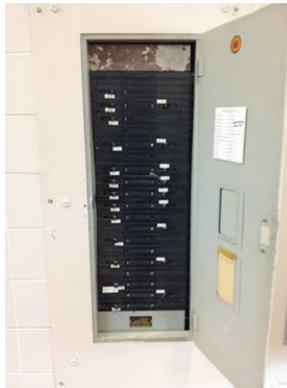
1. One of Kitchen panels appear to be old/beyond its life expectancy. Power feeder associated with this panel is beyond its life expectancy (fig 1).
2. Kitchen receptacles are non-GFCI type and have no GFCI protections (circuit breakers) which is not in compliance with the current electrical code (MEC), (fig 2).
3. Existing lighting control system does not comply with the current energy code: there are no occupancy sensors, no daylight sensors, and no programmable lighting control system for interior lights.

FIG 1: OLD PANEL

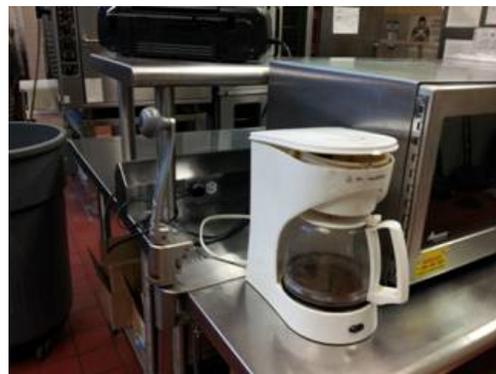
FIG 2: NON-GFCI RECEPTACLES

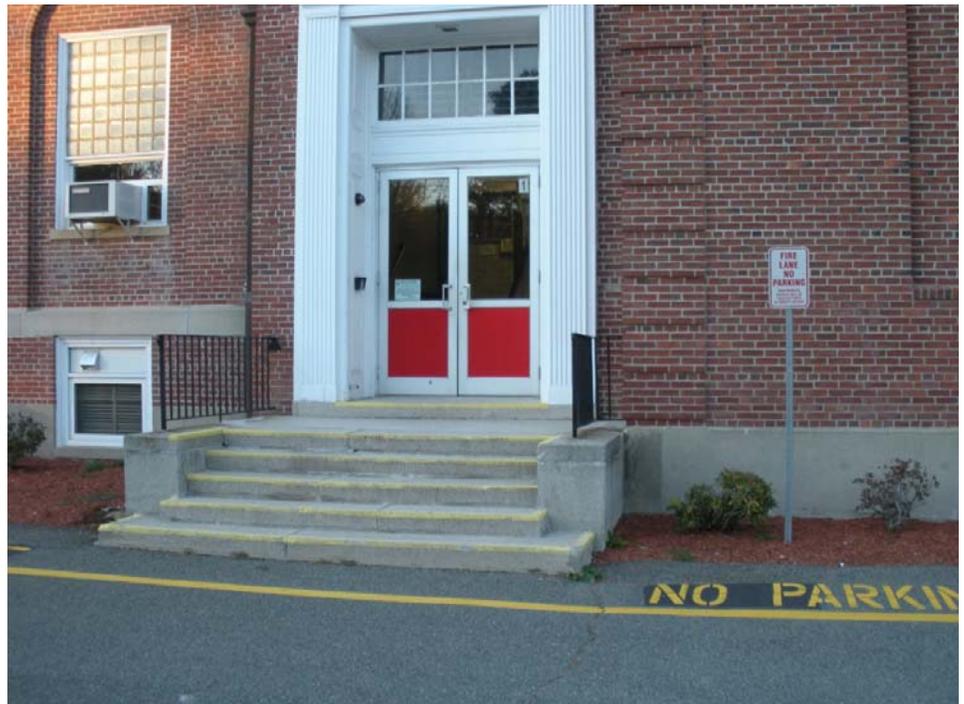
NON-ACCESSIBLE FRONT ENTRANCE AND NON-COMPLIANT HANDRAILS

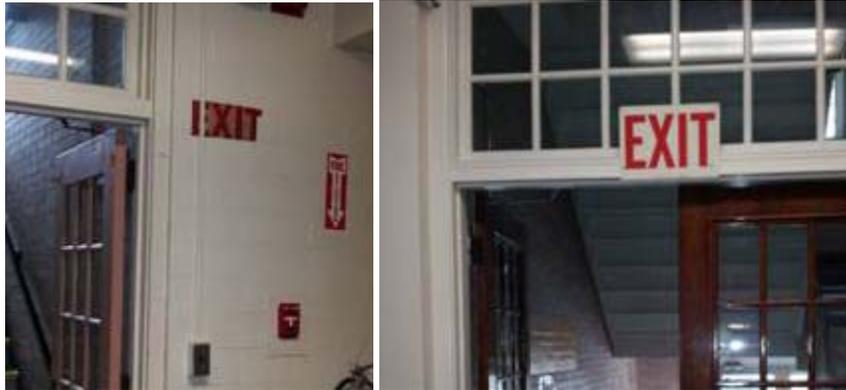
FIG 2: EXISTING EXIT SIGNS

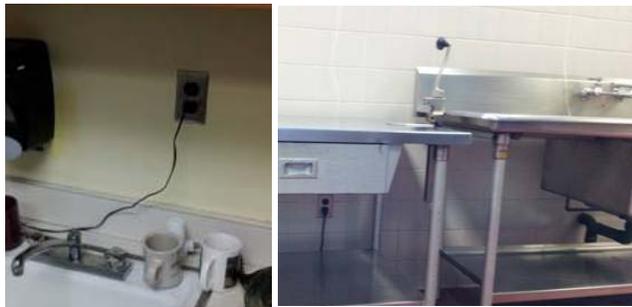
FIG 3: RECEPTACLES NEAR SINKS

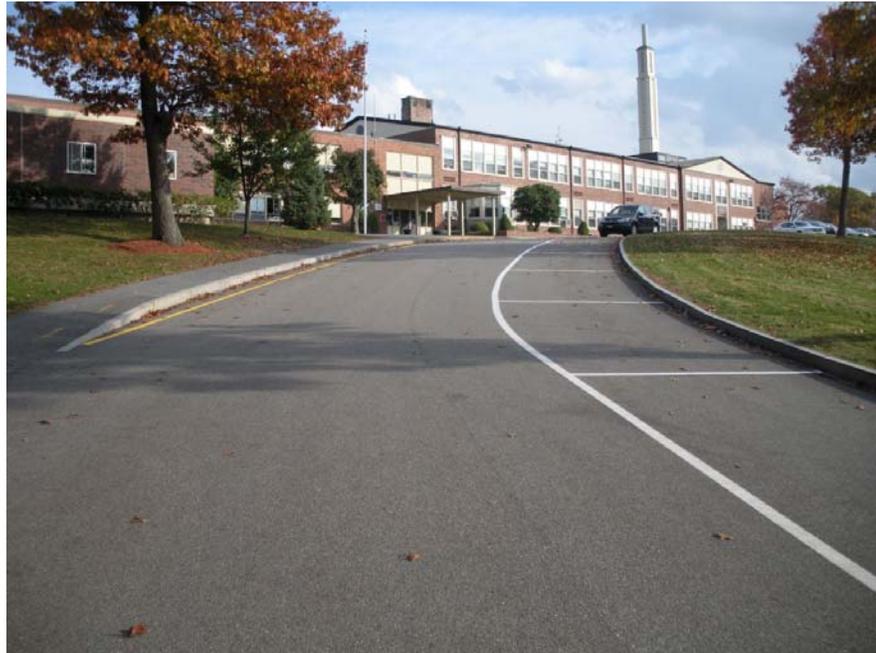
WALKWAY ALONG FRONT BUS/PARKING LOOP THAT EXCEEDS MAAB SLOPE REQUIREMENTS

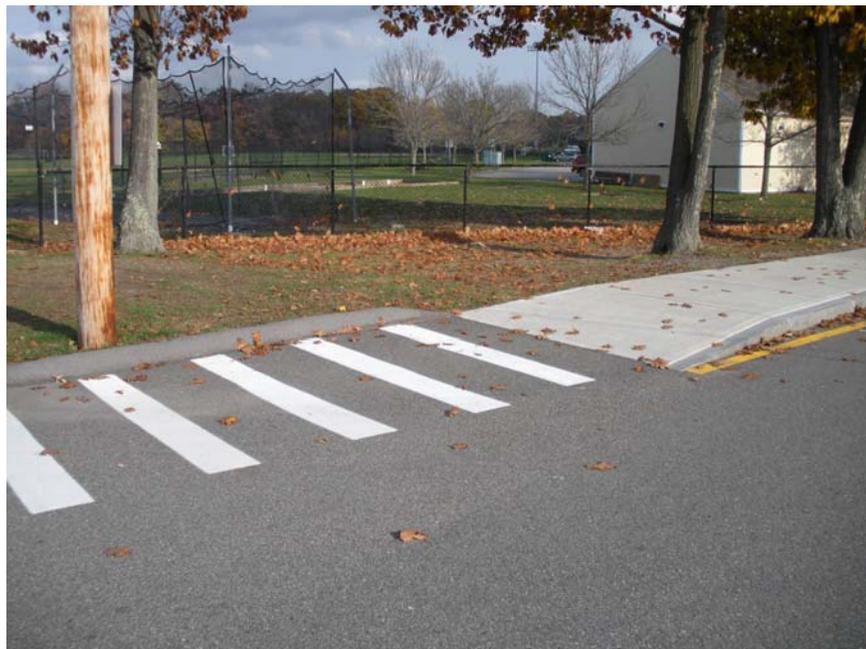
CURB RAMP LACKING DETECTABLE WARNING STRIP AT INTERSECTION OF FRONT BUS LOOP AND PARENT QUEUE LOOP

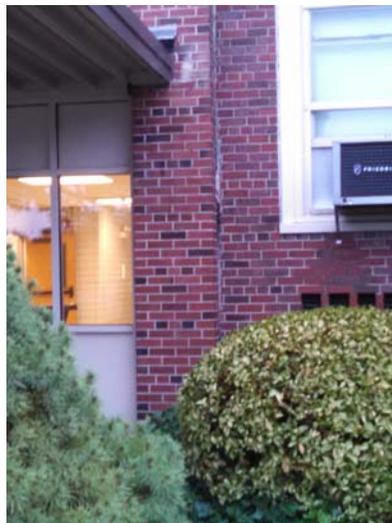
REPOINT BRICKS AT MAIN ENTRY

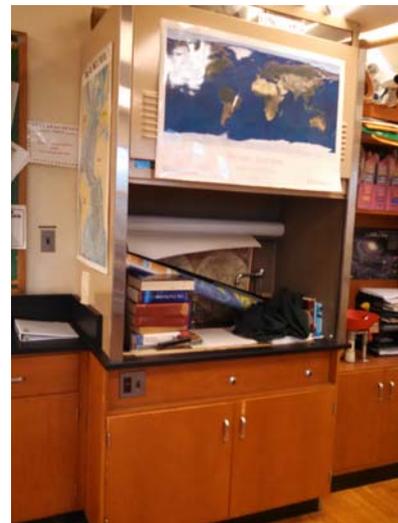
SCIENCE LAB CASEWORK IS WRONG FOR MS

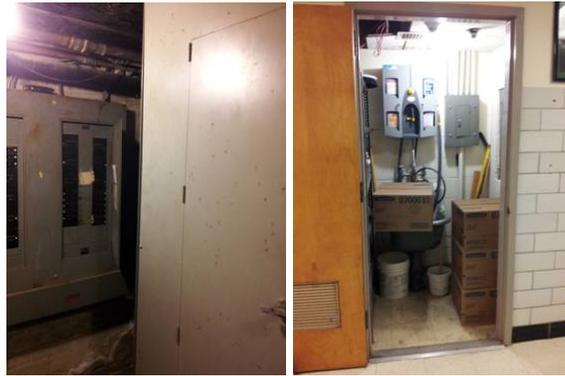
1. Majority of power distribution panels are old/beyond their life expectancy, and some panels became obsolete. A few panels (kitchen panels, janitor closet panels, gym panel) are installed in violation of the electrical code for clearances. Power feeders associated with “old” panels are beyond their life expectancy (fig 1).
2. Kitchen receptacles are non-GFCI type and have no GFCI protections (circuit breakers), which is not in compliance with the current electrical code (MEC), (fig 2).
3. Existing lighting control system does not comply with current energy code: although there are occupancy sensors in classrooms, the rest of lights are controlled by switches only (no occupancy sensors). Also, there are no daylight sensors in the building.

FIG 1: POWER DISTRIBUTION PANELS
